# NAFLIC

TECHNICAL BULLETIN — MAY 2007

## 326. Fabbri Amusements Bulletin for Megadrop Ride

To: Whom It May Concern,  
Re: Mega Drop Amusement Ride  
Fabbri Amusement Manufacturing S.r.l.  
Sub: Over the Shoulder Restraint  
Cracking

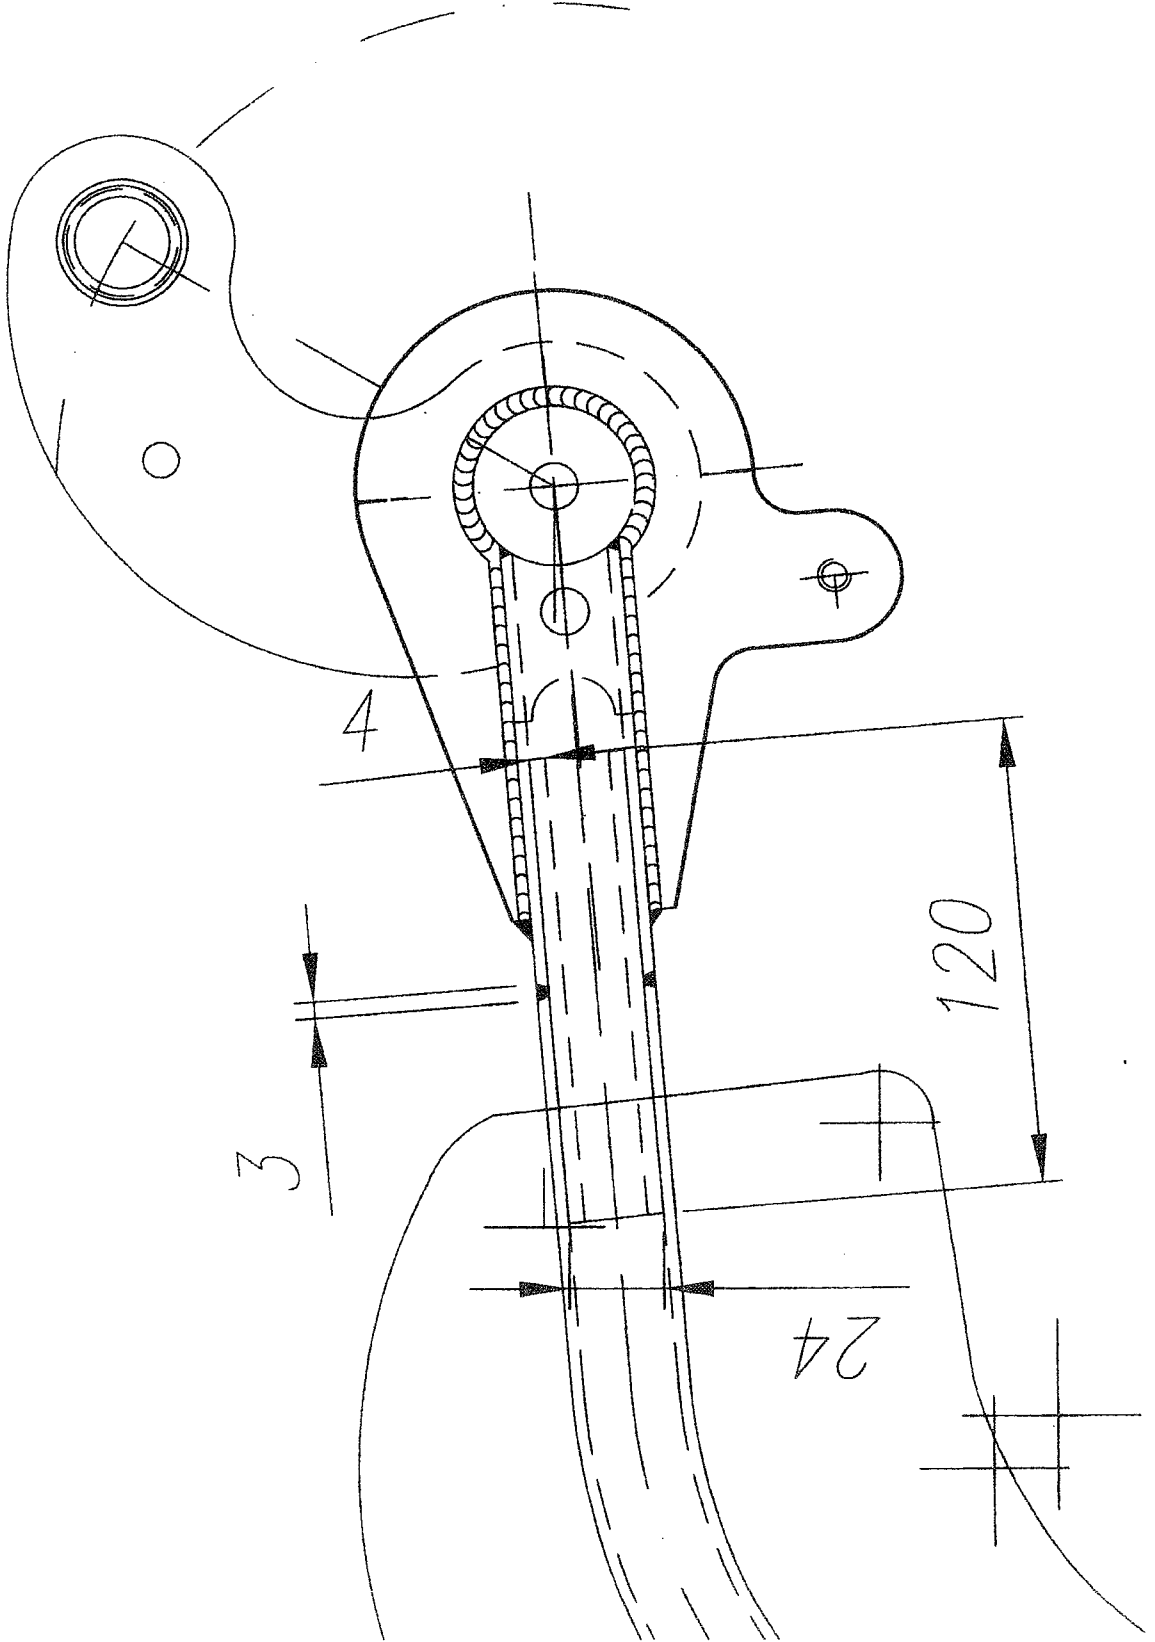
This is the first time we have such this problem on a mega drop and it seems strange because on this ride the forces on the lap bar are very low.

- 1) Clean the cracks on each lap bar with the grinding machine.
- 2) Prepare internal reinforces for the lap bar: Hollow circle diameter 24 mm thickness 3 or 4 mm length 120 mm material S355JO.
- 3) Prepare the edges of the pipe of the lap bar at 20°.
- 4) Weld with basic electrode type **E 7018 AWS 5.2**.
- 5) Make a non destructive test on the weldings, (penetrant liquids).
- 6) Inspect the situation every day.
