# NAFLIC

TECHNICAL BULLETIN — AUGUST 2010

## 365. Kolmax Plus Miami Trip HSE Safety Alert

### KOLMAX PLUS MIAMI TRIP

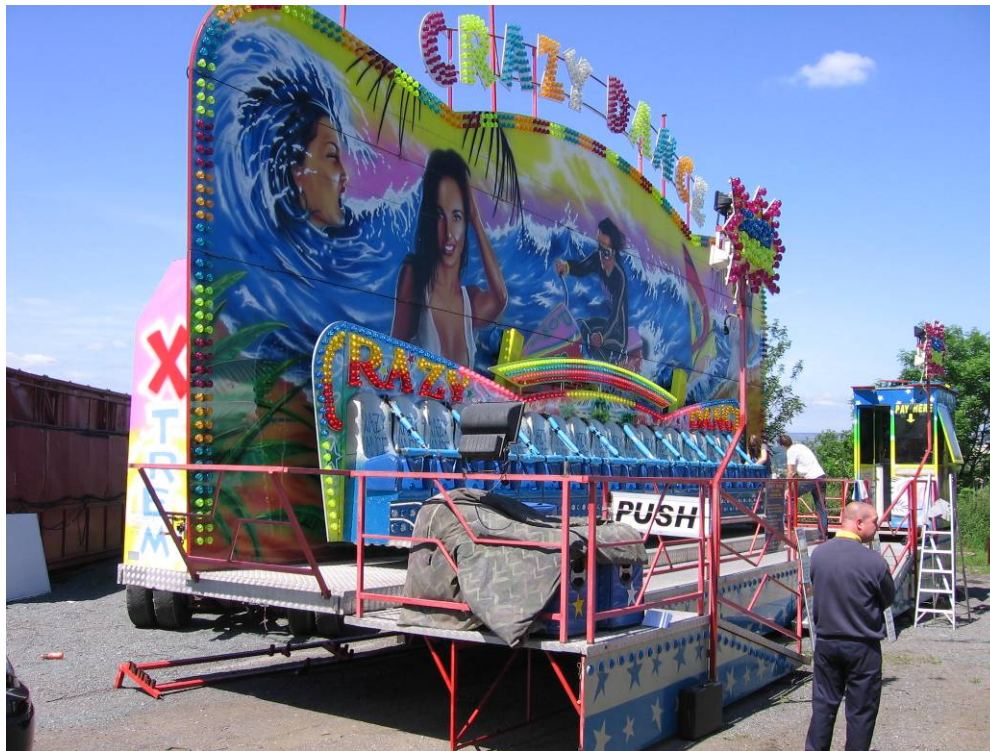
**Fig 1.**

On 12 June 2010 at Halifax a young, disabled person was injured when they were ejected from the right hand end seat a 20 seat Kolmax Plus Miami Trip ride. The ride had been manufactured in the Czech Republic in 2004. See Fig 1.

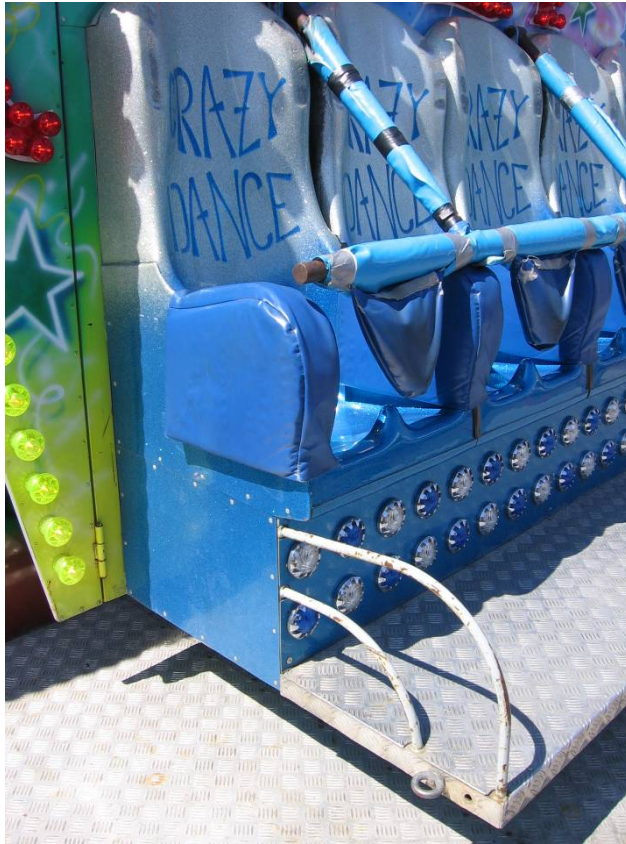
**Fig 2.**

It is believed that at the time of the accident the overhead restraint bars were properly fastened. It is probable that the injured person came out of the ride when her upper body moved forward of the existing shoulder restraint and then the natural movement of body weight caused her to topple over the side of the seat and then out of the ride (see fig 2).

**Action Required - 1:** With immediate effect no passengers should be seated in the last outside seats of these devices, on either side, until a supplementary restraint system/bars has been fitted to prevent a person being ejected from the ride. It is understood that design review work in this area has been started by the showman involved in this incident in consultation with an ADIPS approved design reviewer. The restraint system or bars should be fitted so that they do not cause any trapping

hazard and should be padded to prevent injuries when riders contact them during the ride.

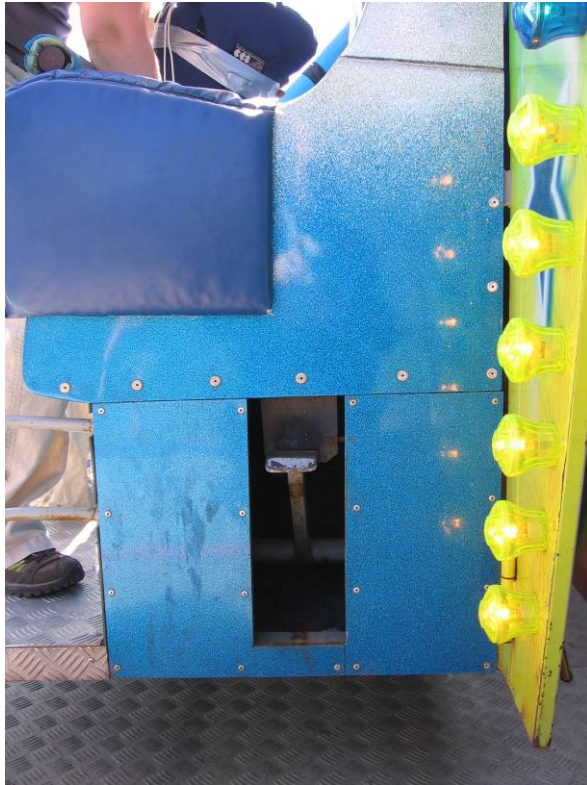
**Fig 3.**

**Action Required – 3:** At the end of the ride cycle the restraint bars are released by the operator pushing down a pedal on the side of the gondola. See Fig 3. This pedal can be reached and activated by the passenger sitting in the end seat nearest the pedal. This access is to be prevented. This may be done by fitting a shroud around the pedal housing so that passengers cannot reach the pedal or by designing the restraint bars mentioned above such that they prevent passengers reaching the pedal.

Any shroud should not be fitted such that it creates a further risk to the operator when unloading the ride.
