# NAFLIC

TECHNICAL BULLETIN — July 2014

## 373 Coupling failure on rollercoaster train – track impact implications

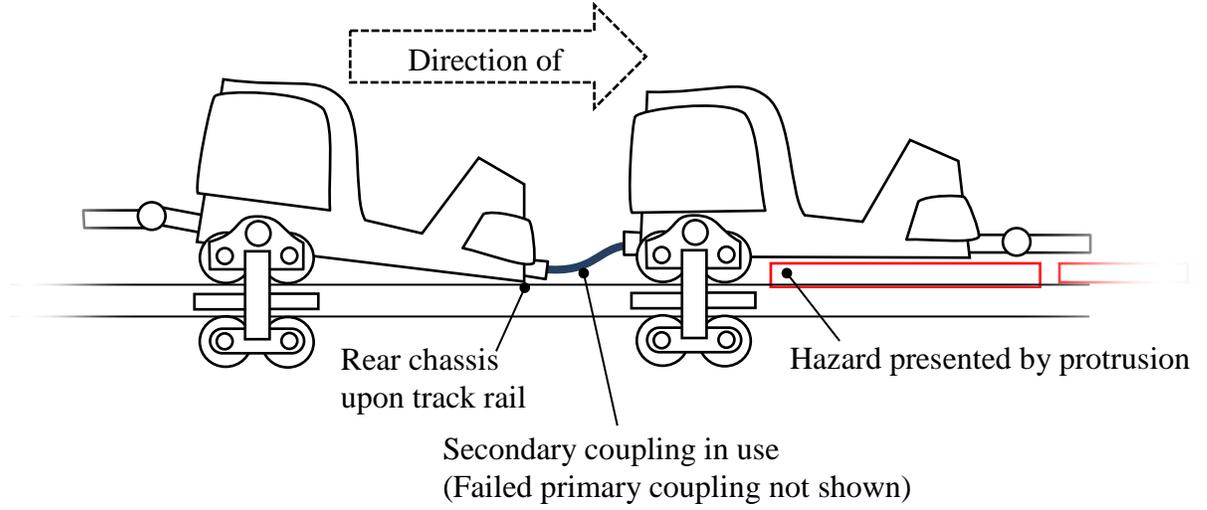
Often the secondary coupling provided in the case of primary failure is a steel wire rope. Whilst this is satisfactory in maintaining the coupling of the train, it is liable to allow the following trailer to move closer to or so that the front end is supported directly upon the track rails. Depending upon the speed and the location of the train when a coupling fails, there could therefore be a significant impact hazard from any protruding elements (such as brake fins, drive motor wheels etc.), that although usually clear of the train envelope, now would encroach the lowered car, presenting an impact hazard.

Please also be aware, in cases where cars of a roller-coaster train have 2 axles, of the risks of the coupling failing, and the coupling bar itself striking parts of the track structure (e.g. cross members) or protruding elements.

It is therefore recommended that where an impact hazard exists, due to the combination of the circumstances (trailer-type configuration train, secondary wire rope attachment that allows significant vertical movement of a car in case of primary failure, and components or assemblies that protrude above the rails), that an appropriate risk assessment be carried out, and actions to eliminate the hazard implemented.
