Eli Bridge Company
800 Case Avenue
Jacksonville, IL 62650
USA
Phone: 217-245-7145 FAX: 217-479-0103
Email: Elibridge@aol.com
Website: www.EliBridge.com

Bulletin No.: 060131-1
Release Date: January 31, 2006
Effective Date January 31, 2006
Supercedes: None
Completion Date: As Necessary
Page 1 of 1

SERVICE BULLETIN

Ride Manufacturer: Eli Bridge Company
Ride Names: All BIG ELI[®] Aluminum Wheel Seats

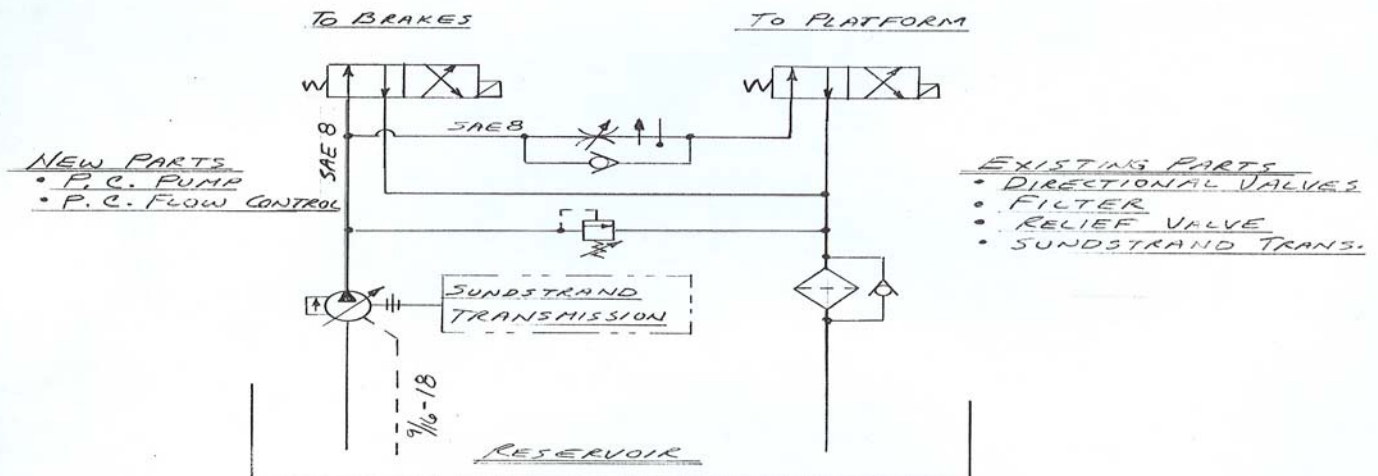
Reason For Release: The present circuit design for the hydraulic brakes and platform are inefficient using more parts than necessary and presently creating most of the heat load in the circuit. These systems are very important safety issues of the ride and must function flawlessly. There are several ways of reducing the heat generated in these circuits but brake pressure must be held at all times. Therefore the best circuit revision will be to replace the existing brake gear pump with a pressure compensated pump used for the brake and platform circuit. By limiting the flow to the platform cylinder to less than full pump flow, we maintain constant brake pressure. The heat generated by this circuit is about 1/4 of the present heat load. Another major benefit to this revision is the elimination of the separate power unit for the platform circuit. The new pump is driven off the main 30 HP drive which now will be the only power unit required for the Aristocrat. The Eagle has a separate power unit for setup, which could be eliminated by using oil from the new pump, but because the required pressures are so different, it is advisable to maintain the setup circuit as is and shut this unit off after setup.

Action to be taken: Replace the auxiliary brake gear pump with the new pressure compensated pump, remove the separate platform pump and motor, and tie these two circuits together as proposed by the Eli Bridge Co. circuit upgrade.

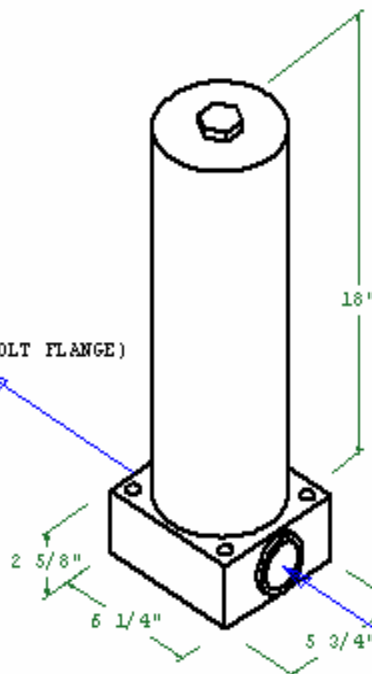
Reason for Release: The hydrostatic transmission (The Sundstrand #90L100) unit is the most important and expensive part of the hydraulic drive system. **To prolong the life of the unit**, a pressure filter in the closed loop circuit can now protect it. The Wheel drives forward about 80% of the time so the most cost effective and beneficial location of a filter would be on the return side of the closed loop in the forward mode. Eli Bridge Company offers a filter upgrade unit that can be installed between the return line of the wheel drive motors and the transmission "B" port.

Action to be taken: Install a pressure filter designed for hydrostatic transmission use on the return side of the closed loop in the forward mode to insure long and trouble free service for the owner. This will filter all oil before it returns to the transmission while running in the forward direction and through a reverse free flow check valve when running in reverse. The filter element is a 10-micron unit capable of holding a large capacity of 108 grams dirt. The housing has a pointer indicator to show the condition of the filter. Port size will be SAE-24 straight threads for O-ring seals for the most leak free installation. Call the factory for pricing and availability.

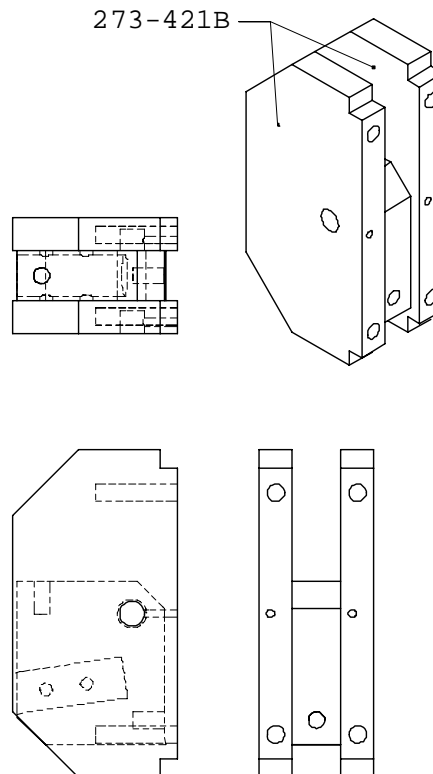
Reason For Release: It has been brought to our attention that it is possible to pinch fingers between the lap bar pivot block and the lap bar hinge blocks if care is not used.

Actions to be taken: Eli Bridge Co. has redesigned a wider lap bar hinge block that covers the sweep of the lap bar pivot block movement to minimize the possibility of pinching the fingers when raising or lowering the lap bar. The suggested replacement part # is 273-421B which consists of 4 lap bar hinge blocks that can be screwed to the existing door in place of the original block # 273-421A. All existing components are reused with the wider hinge blocks. Two 5/16 -18 x 3/4" long pan head screws (stainless steel) hold the hinge blocks to the handle bar.
