SAFETY ALERT/ACTION NOTE

KOLMAX PLUS MIAMI TRIP

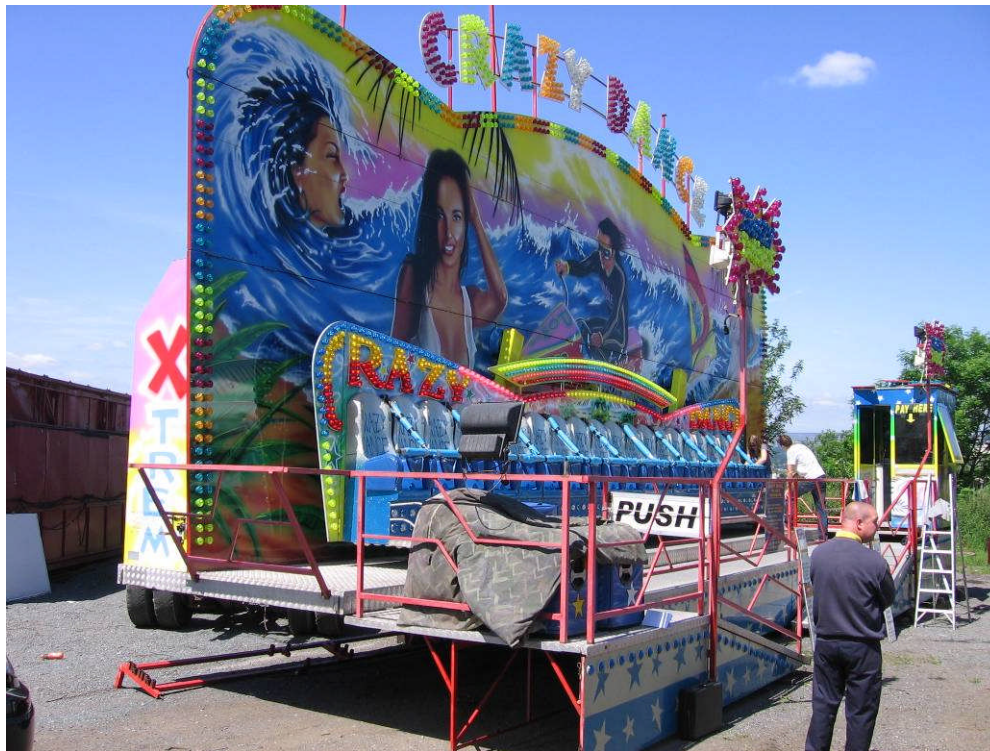
On 12 June 2010 at Halifax a young, disabled person was injured when they were ejected from the right hand end seat a 20 seat Kolmax Plus Maimi Trip ride. The ride had been manufactured in the Czech Republic in 2004. See Fig 1.

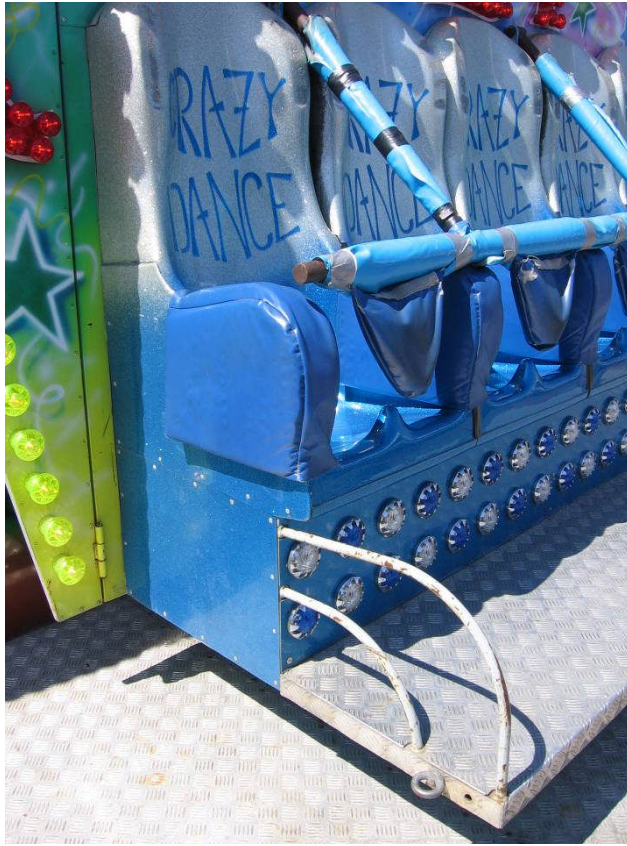
It is believed that at the time of the accident the overhead restraint bars were properly fastened. An ergonomic and ride force study is currently being undertaken to examine these aspects of the containment system. However, it is believed that she was able to fall sideways from the right end seat. The left side seat is shown in Fig 2.

Action Required - 1: With immediate effect no passengers should be seated in the last outside seats of these devices, on either side, until a supplementary restraint system/bars has been fitted to prevent a person being ejected from the ride. It is understood that design review work in this area has been started by the showman involved in this incident in consultation with an ADIPS approved design reviewer. The restraint system or bars should be fitted so that they do not cause any trapping

hazard and should be padded to prevent injuries when riders contact them during the ride.

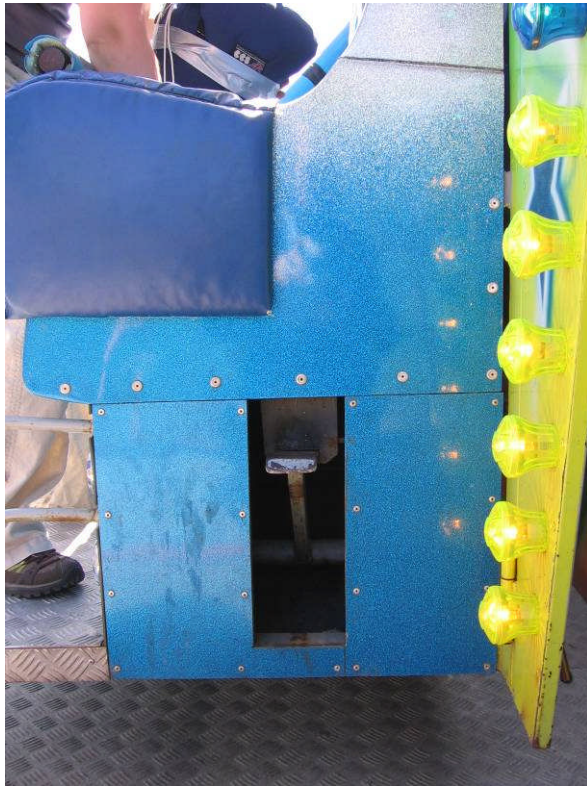
Action Required – 3: At the end of the ride cycle the restraint bars are released by the operator pushing down a pedal on the side of the gondola. See Fig 3. This pedal can be reached and activated by the passenger sitting in the end seat nearest the pedal. This access is to be prevented. This may be done by fitting a shroud around the pedal housing so that passengers cannot reach the pedal or by designing the restraint bars mentioned above such that they prevent passengers reaching the pedal.

Any shroud should not be fitted such that it creates a further risk to the operator when unloading the ride.
