SAFETY NOTE REVERCHON LOG FLUME
INVESTIGATION DETAIL AND CONTROLLER ACTIONS REQUIRED

This alert is an update to the Reverchon Log Flume Safety Alert sent out 20 September 2011 and should be read in conjunction with it. Both Alerts refer to the same accident on 27 August 2011 involving a machine manufactured in 1998 which resulted in injuries to two riders.

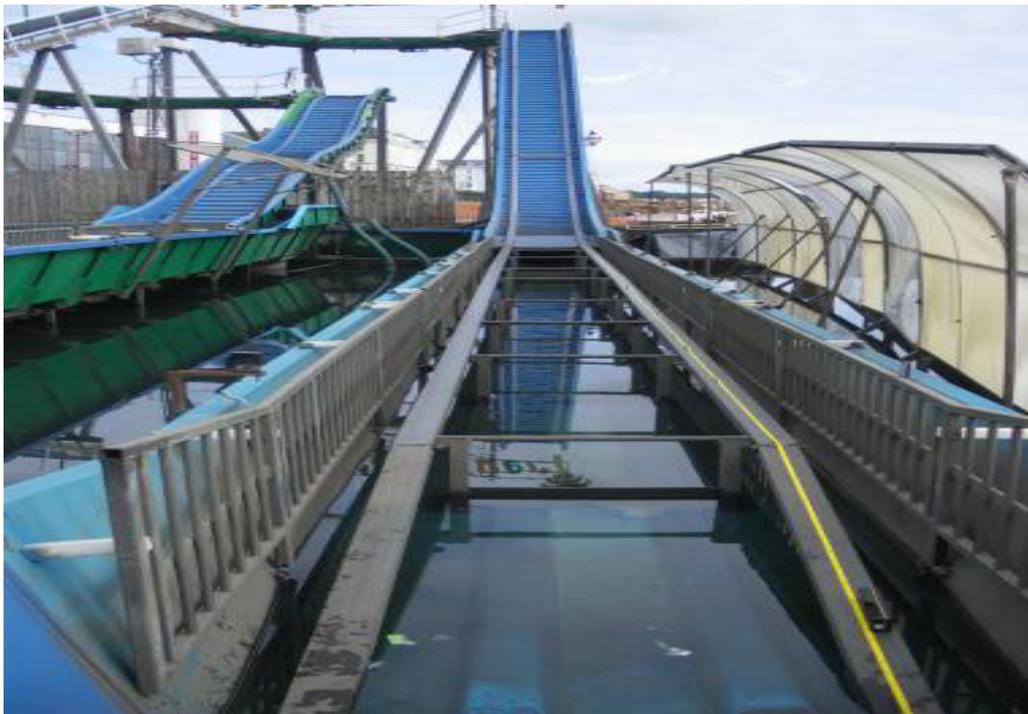
The investigation was carried out following an incident involving a Reverchon log-flume ride. It identified that the safety of the ride was critically dependent on the level of water within the "splash zones" immediately after the drops. As the cars enter the splash zones they ride on supporting rails which set the cars at a shallow down angle. This means that the farther along the splash zone the car travels, the deeper the water it encounters. The front of the car is designed to generate a bow wave which resists forward motion (i.e. slows/brakes the car) as it moves through the water. Effective braking of the car therefore is totally dependent on the water being at the correct level in relation to the height of the rails. The water level in the splash zone is effectively the brake and is a safety critical element of the ride. It is this which prevents the log flume car hitting the 90° bend at the end of the splash zones at high speed, potentially ejecting any passengers. The optimum water level is achieved once the ride has achieved its steady state condition (i.e. the splash zone channel completely filled with water). If the main water pump is not running or is not pumping properly, the water will naturally flow back from the channels and into the main reservoir.

Splash tank and rails

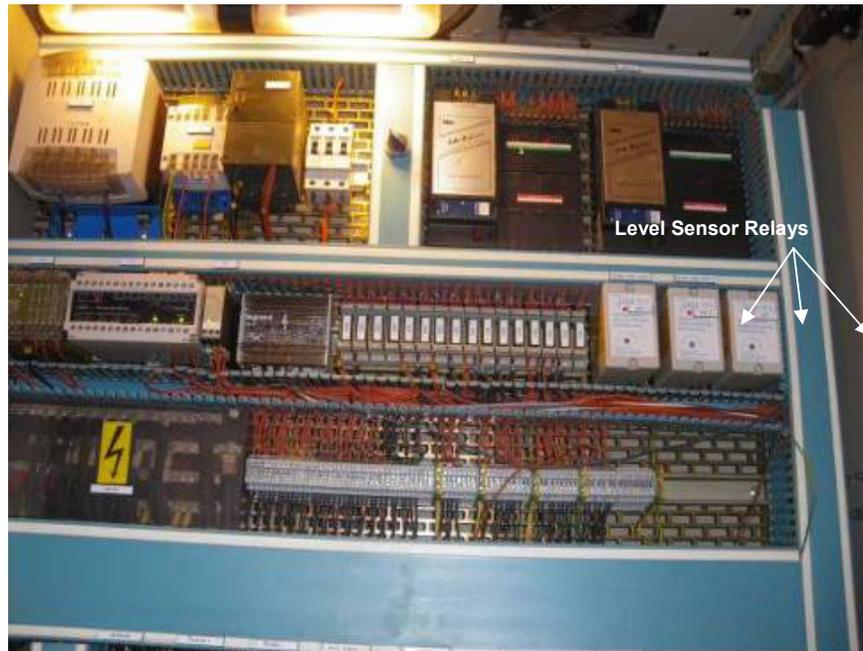
1. **If the water level relays situated in the ride's control panel, were to either fail in the ON state, or were incorrectly calibrated.** In both circumstances it is possible for the cars to be released from the top of either drop with little or no water in the splash zones and therefore, little or no braking. To overcome this concern, it is recommended that an automatic check by the control system should be implemented prior to the start-up of the ride. If the water level sensor relay for either water splash is in the ON state before the main pump has been started, operation of the ride shall automatically be prevented. This check could be carried out either by the PLC or by simple hardwired means. It should be noted that this does not absolve the ride controller from carrying out appropriate pre-use and in-use checks.

Level Sensor Relays in Electrical Control Panel

Due to the complex nature of the electronic control system on this machine, controllers should ensure that any work done on it is completed and tested by a person competent to do so.

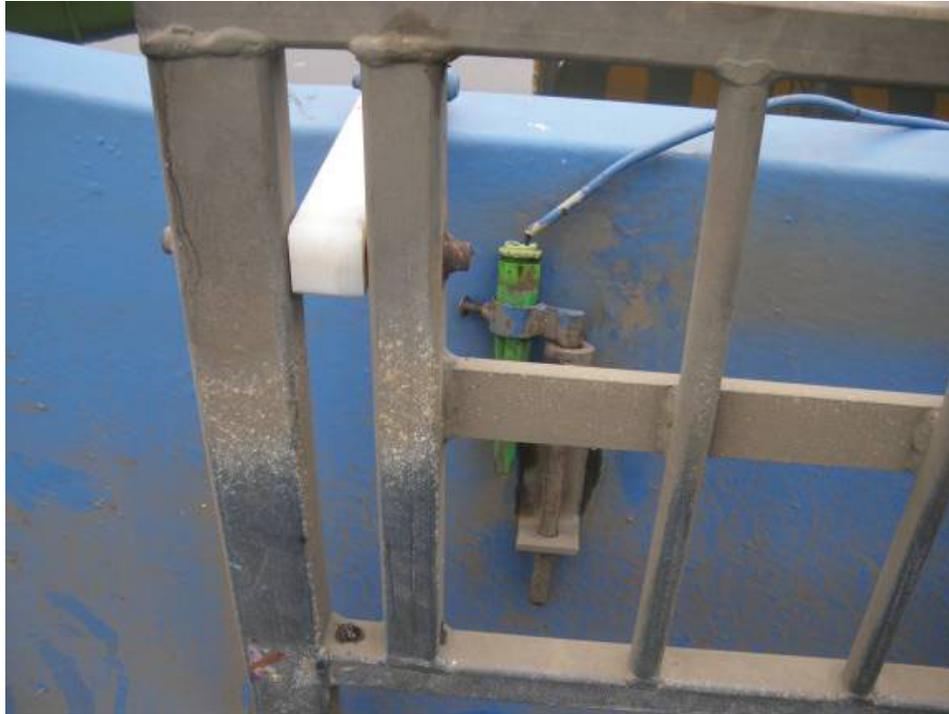
2. **If the level probes for the water-level relays are positioned at too low a level.** This could allow the first car to descend either drop, particularly if the ride has been restarted with the car already positioned near the top of the drop, and to enter the splash zone before the system has reached its steady state condition. To prevent this from occurring, the water level probes should be relocated such that the relays are actuated with the water as near to steady state conditions as possible. In order to achieve this, the existing probe adjustment system may require modifying or redesigning.

Level Sensor Probe

During the investigation information was received from other controllers and operators that discarded paper, leaves and accumulations of human hair etc can become attached to the level sensor probes, sometimes causing false signals in the control system. Controllers should ensure that sufficient water is in the machine at all times when it is running and that the water is clear of rubbish and litter.
