SERVICE BULLETIN

SUBJECT: REPLACEMENT OF DRIVE STEEL ROPES OF RADIAL ARMS.

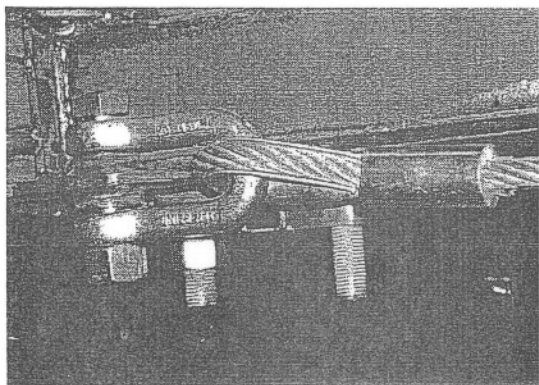
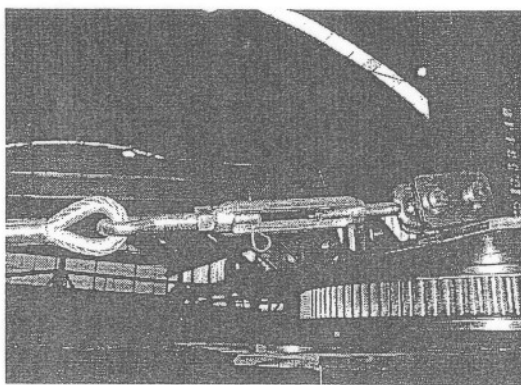
As a safety precaution, BERTAZZON 3B srl requires all owners of Matterhorn rides manufactured by Bertazzon 3B amusement rides with the above noted serial numbers to perform the modification described within this bulletin. This modification will provide reduction risk of breaks of thimbles at the edge of the ropes. Clients may decide not to install the above safety kit at their sole own risk.

All driving steel ropes (total q.ty 8 ropes) are to be replaced with the new ones. Each old roping (consisting of a steel rope, a clevis, a tightener and the related bolts and nuts) must be removed keeping the threaded piece of the tightener.
