ALERT relating to amusement ride Break Dance
SERVICE LETTER No. 17-10

Ref.: «Typ» of serial number «Bau_Nr»

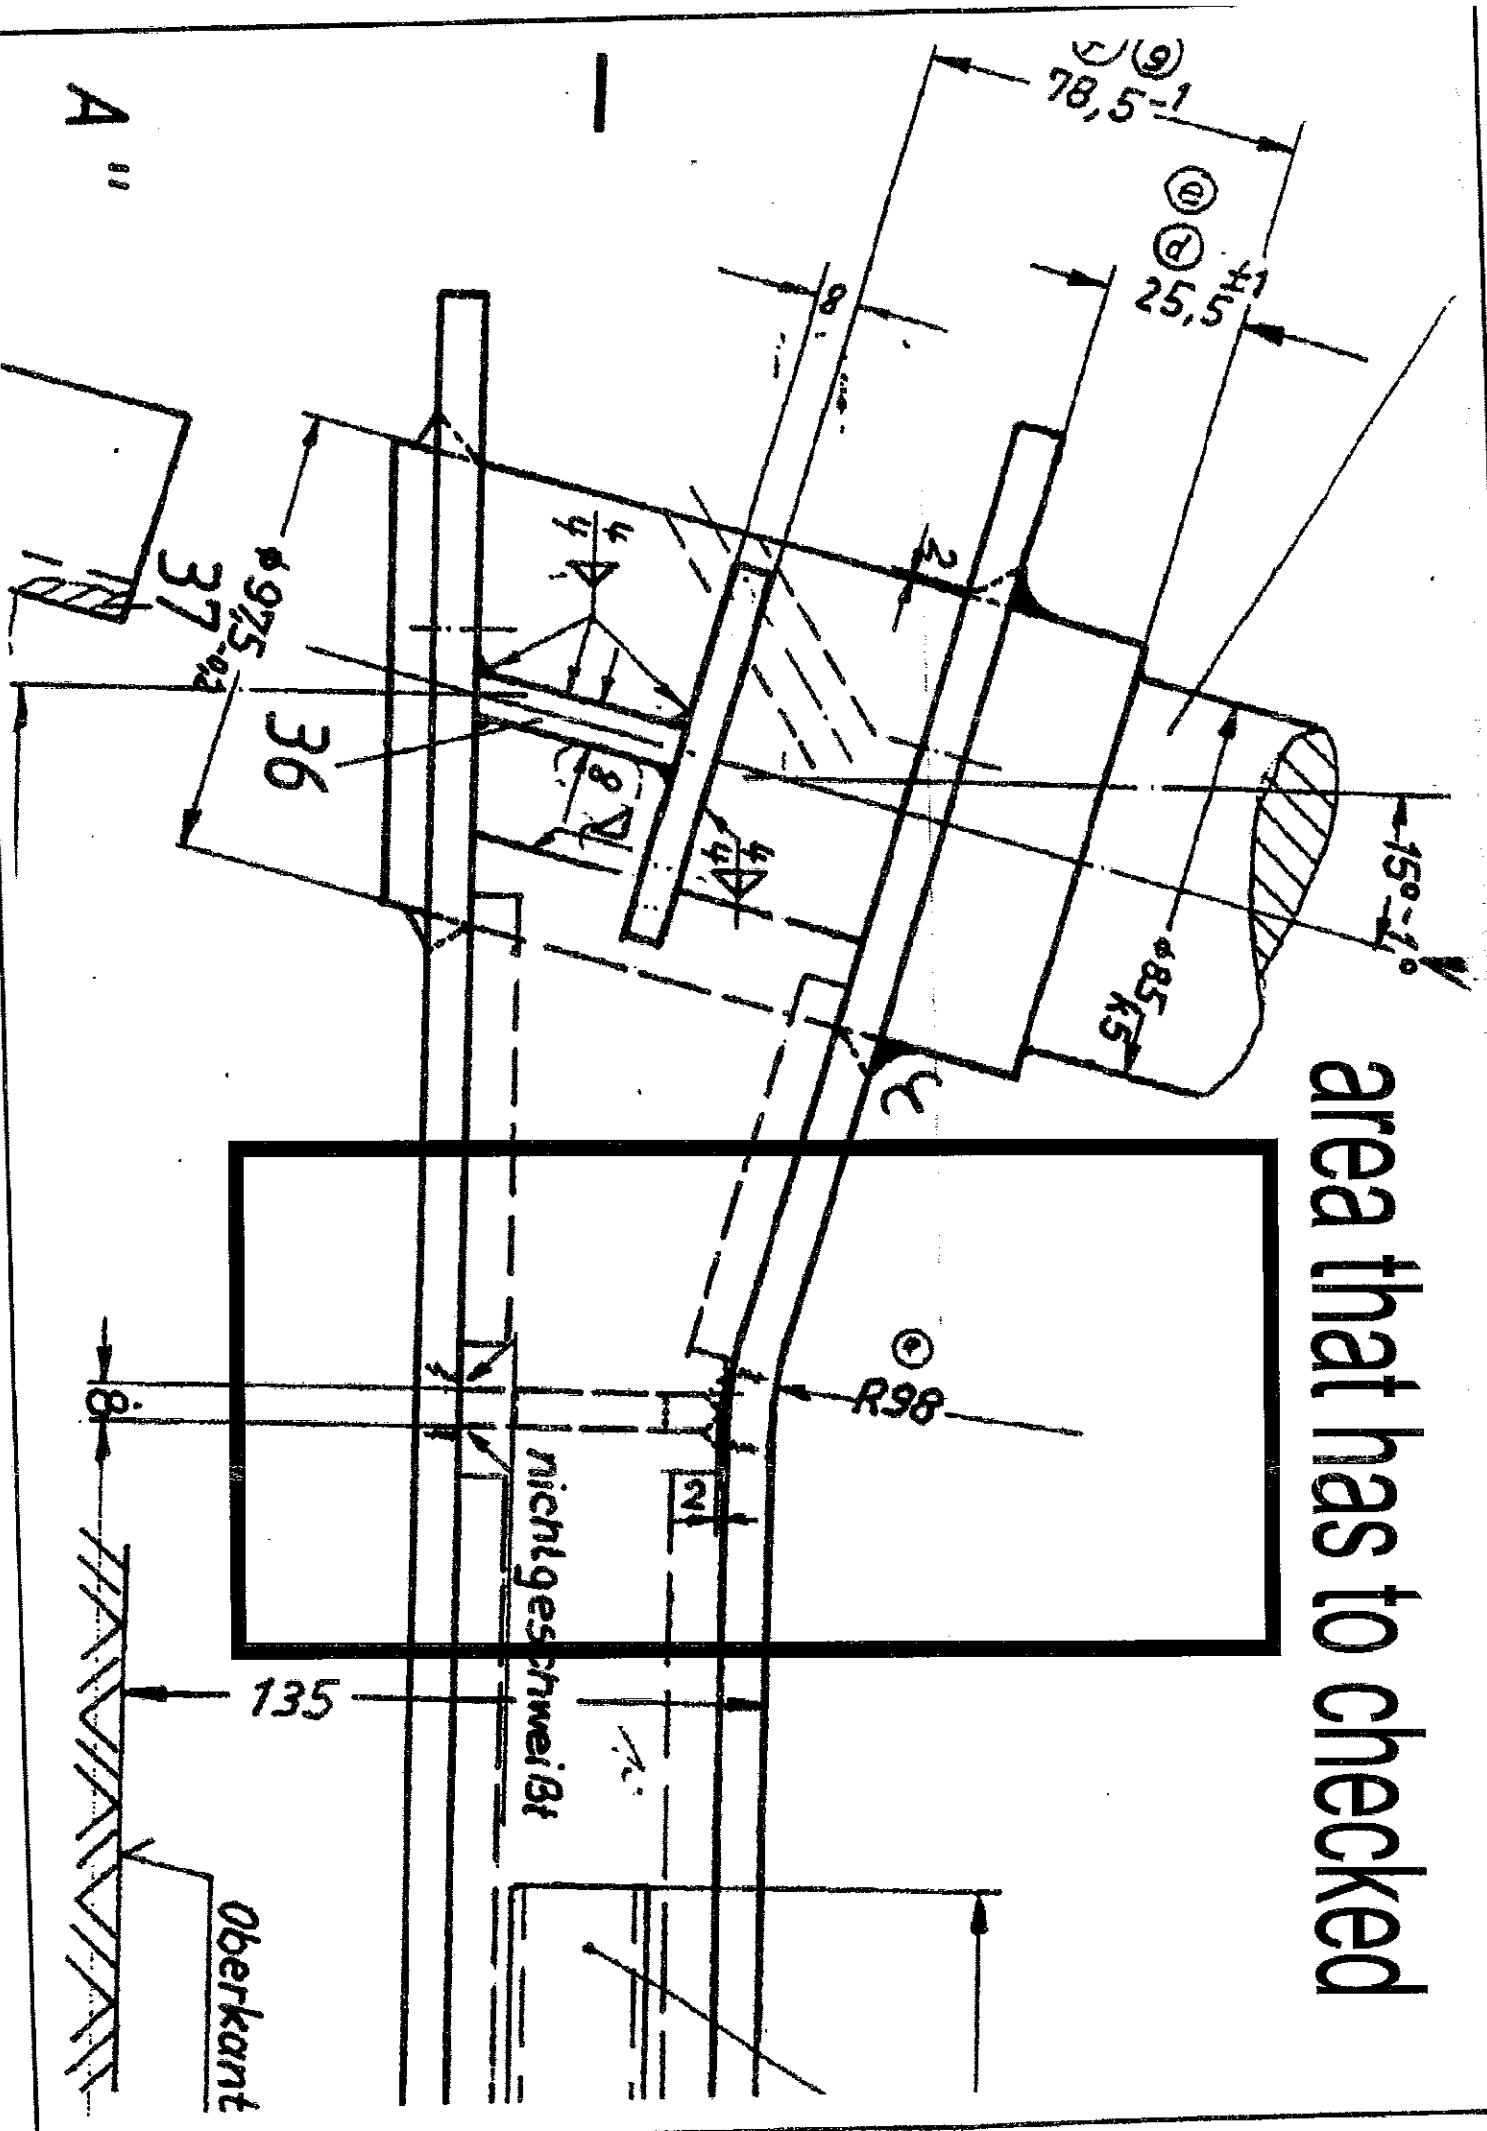
Recently, cracks occurred at the gondola booms of two German „Break Dance“ rides. Thus, and with reference to our Service Letter 17-08 of 1999, we have to insist on the following measures being taken immediately.

1. Upon receipt of this Service Letter and before operating your Break Dance ride again, please visually check all the booms thoroughly and specially test the **break area at the gondola** (see enclosure) for cracks and irregularities. In case you do not feel able to do it yourself, please either contact the manufacturer or certified materials testing lab.
2. In case of visually detected irregularities, damages or cracks the ride must be shut down immediately and an ultrasonic inspection must be carried out either through a company authorised by the manufacturer or a certified amusement ride inspection agency or through an accredited testing laboratory. A report of the test results under (1) and (2) has to be submitted to the manufacturer immediately, however, no later than September 20, 2005.

area that has to checked

3. Even if there are no irregularities – this means no visual deficiency was detected – an ultrasonic inspection must be carried out either through a company authorised by the manufacturer, a certified amusement ride inspection agency or through an accredited materials laboratory **at the break area of the gondolas boom** (see enclosure) at all gondola booms of your ride through latest until September 20, 2005. The test results have to be submitted to the manufacturer immediately, however, no later than September 30, 2005.

4. Even if no irregularities, damages, cracks etc. were detected during the visual check and the ultrasonic inspection, a visual check of the break area has to be effected **on a daily basis** until the original certification body (TUV) issues further instructions to the proceeding.

5. In case the tests show cracks, the original certification body (TUV) must assess the detected damages. This certification body will also have to approve repair measures.
