"R A I N B O W"

SERVICE LETTER RB-II

Bulletin No: Rainbow Service
Letter 6
Release Date: June 17, 2002
Effective Date: June 17, 2002

Service Bulletin

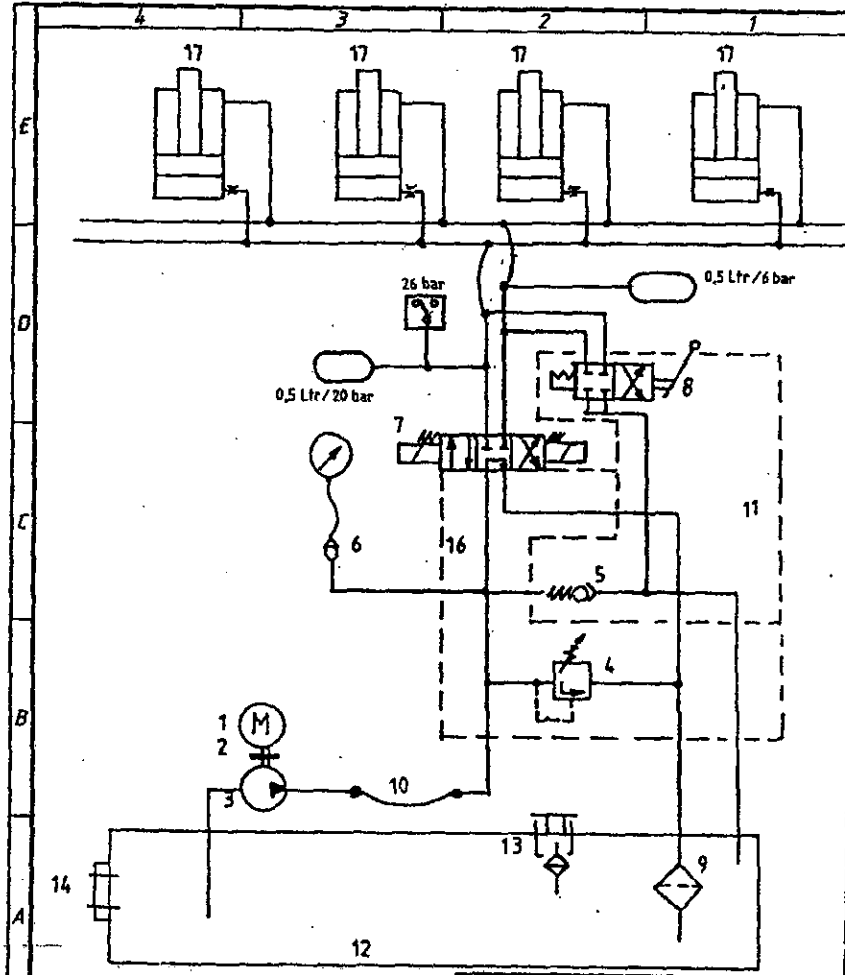
Art. Nr.: 3066916

A review of safety issues involved with the Rainbow gondola restraint system has been conducted and as a result the following upgrades to the safety system are being recommended.

Following a review of the ride's safety system we are now of the opinion that the ride's safety system could be significantly improved with the installation of seat belts, moulded rubber seat inserts and the installation of a hydraulic pressure switch to monitor restraint system pressure.

1. A pressure switch and nitrogen accumulator system should be installed in the gondola's electrical circuit and set to a minimum of 26 Bar to ensure that the ride cannot be started without the minimum hydraulic pressure.
2. Lap belts should be installed on each bench seat.
3. Moulded foam rubber seat inserts should be installed on each bench seat to minimize guests sliding from side to side.
4. The gondola's hydraulic restraint system pressure should be checked on a monthly basis to ensure that it is exerting a minimum of 30 Bar of pressure and the testing of the pressure should be documented in the attractions ride log book on a regular basis.
5. In addition, consideration should be given to installing gates on the gondola. A gondola retrofit package is available from the Huss Service department as an option; see Service Letter circa January 1990.
