From : A. Kroon  
 Subject : Service Bulletin FRB24-SB007  
 Order no. :  
 Our reference : FRB-24

Bulletin No.: FRB24-SB007  
 Ride: Afterburner by KMG International BV  
 Relative Rides: Serial numbers:  
 KMG-XXXX-FRB-24-XXX-001 through and including  
 KMG-XXXX-FRB-24-XXX-036  
 Date of Issue: December 7<sup>th</sup> 2009  
 Date of compliance: As soon as possible / before January 31st 2010.

Regarding: Visual inspection of over the shoulder restraints of passenger seats

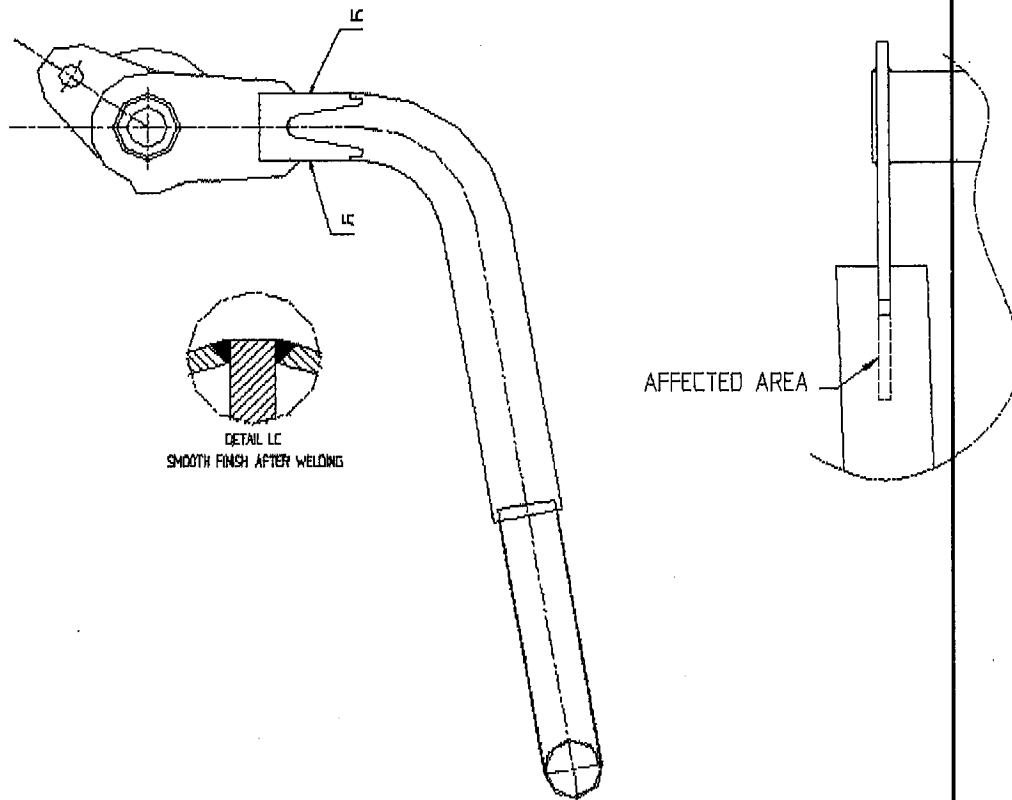
**Situation**

On recent investigation on one of the Afterburner rides, it was discovered that structural steel on some of the over the shoulder restraints showed indications in the weld area. These restraints were shipped back to KMG and underwent destructive testing and examination. It was discovered that the original weld was partially removed in the finishing process after welding, causing the weld area to be weakened in particular areas leaving no bonded material. These non-bonded areas have resulted into visual indications during a visual inspection after removing the foam on the steelwork.

The affected weld area on the over the shoulder restraints is located on the end of the shoulder tube of the restraint where the tube is attached to the connection plate that connects the shoulder tube to the hinge tube. Each shoulder tube has four welds (two on the top side and two on the bottom side of the shoulder tube). Defects are found in the area where the connector plate ends in the shoulder tube as shown in detail LC in the situation shown below.

All over the shoulder restraints on the above mentioned machines need to be visually inspected on both shoulder tubes in the affected area. In this area the padding foam should be slit for four inches and pulled away from the steel to access the inspection area. Care should be taken to not rip the padding when folding it away.

1. Clean all welding surfaces by removing paint, grease and dirt.
2. Grind out the indication by a thin grinding disc.
3. Check if all of the indications are ground deeply enough using MPI.
4. Re-weld the ground out gap by using SMAW (shielded metal arc welding) according to the above detail LC. The weld must be carried out with rod ASW E7015, according the weld detail LC above.
5. Smooth finish the weld according to drawing above by using a small grinder with a sanding paper disc.
6. Check the weld by visual inspection and magnetic inspection by a level I or higher NDT inspector.
7. Protect the steel against corrosion by covering the surface with paint.
