**SAFETY NOTE REVERCHON LOG FLUME**  
**INVESTIGATION DETAIL AND CONTROLLER ACTIONS REQUIRED**

This alert is an update to the Reverchon Log Flume Safety Alert sent out 20 September 2011 and should be read in conjunction with it. Both Alerts refer to the same accident on 27 August 2011 involving a machine manufactured in 1998 which resulted in injuries to two riders.

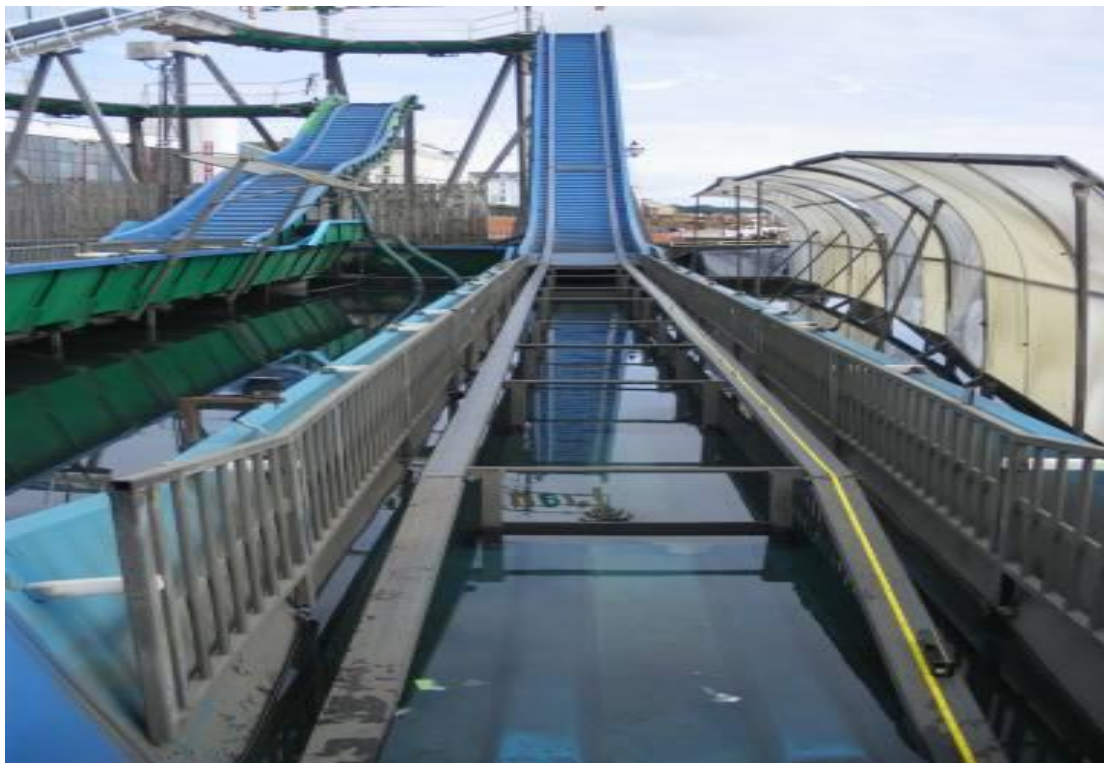
The investigation was carried out following an incident involving a Reverchon log-flume ride. It identified that the safety of the ride was critically dependent on the level of water within the "splash zones" immediately after the drops. As the cars enter the splash zones they ride on supporting rails which set the cars at a shallow down angle. This means that the farther along the splash zone the car travels, the deeper the water it encounters. The front of the car is designed to generate a bow wave which resists forward motion (i.e. slows/brakes the car) as it moves through the water. Effective braking of the car therefore is totally dependent on the water being at the correct level in relation to the height of the rails. The water level in the splash zone is effectively the brake and is a safety critical element of the ride. It is this which prevents the log flume car hitting the 90° bend at the end of the splash zones at high speed, potentially ejecting any passengers. The optimum water level is achieved once the ride has achieved its steady state condition (i.e. the splash zone channel completely filled with water). If the main water pump is not running or is not pumping properly, the water will naturally flow back from the channels and into the main reservoir.

Splash tank and rails

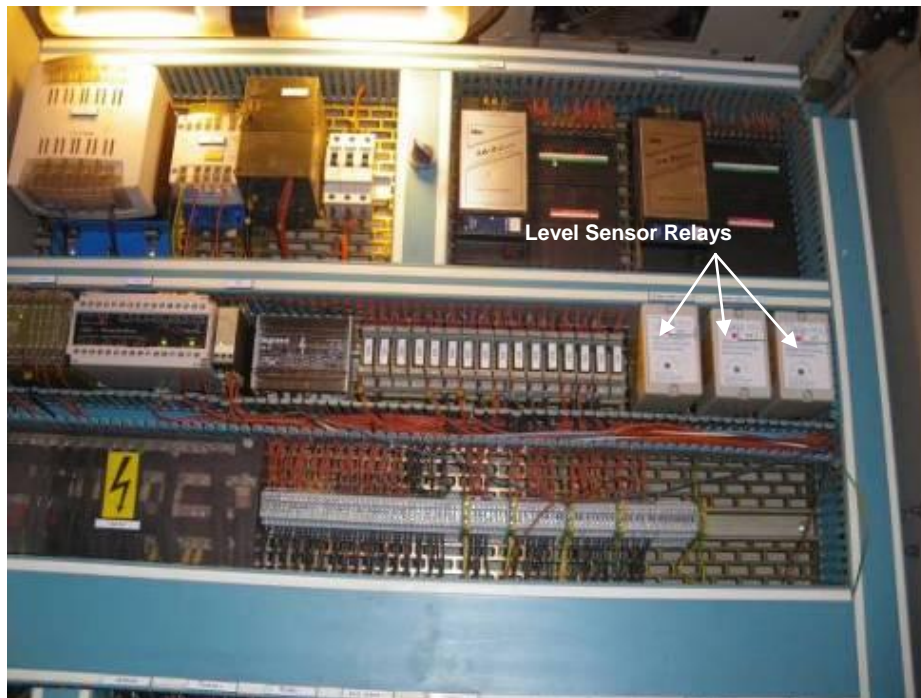
1. **If the water level relays situated in the ride's control panel, were to either fail in the ON state, or were incorrectly calibrated.** In both circumstances it is possible for the cars to be released from the top of either drop with little or no water in the splash zones and therefore, little or no braking. To overcome this concern, it is recommended that an automatic check by the control system should be implemented prior to the start-up of the ride. If the water level sensor relay for either water splash is in the ON state before the main pump has been started, operation of the ride shall automatically be prevented. This check could be carried out either by the PLC or by simple hardwired means. It should be noted that this does not absolve the ride controller from carrying out appropriate pre-use and in-use checks.

Level Sensor Relays in Electrical Control Panel

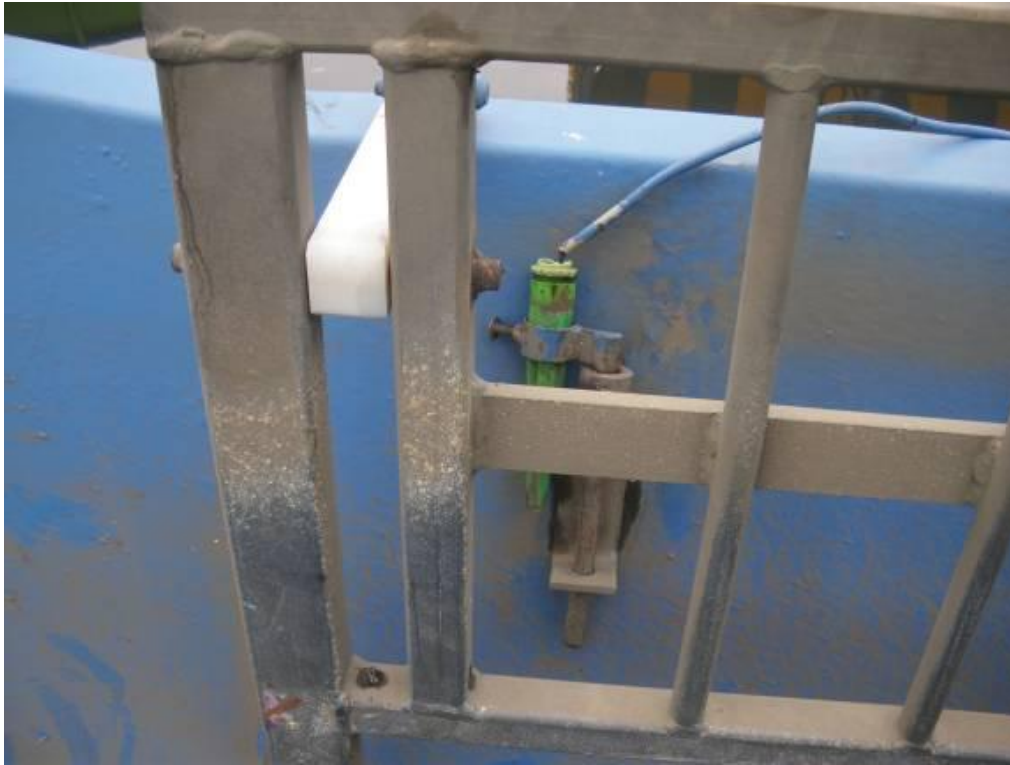
2. **If the level probes for the water-level relays are positioned at too low a level.** This could allow the first car to descend either drop, particularly if the ride has been restarted with the car already positioned near the top of the drop, and to enter the splash zone before the system has reached its steady state condition. To prevent this from occurring, the water level probes should be relocated such that the relays are actuated with the water as near to steady state conditions as possible. In order to achieve this, the existing probe adjustment system may require modifying or redesigning.

Level Sensor Probe

During the investigation information was received from other controllers and operators that discarded paper, leaves and accumulations of human hair etc can become attached to the level sensor probes, sometimes causing false signals in the control system. Controllers should ensure that sufficient water is in the machine at all times when it is running and that the water is clear of rubbish and litter.
