TECHNICAL BULLETIN

Our ref. no. ZAMP/9208GA-UK

Subject : MAIN SWINGING PIVOT SHAFT

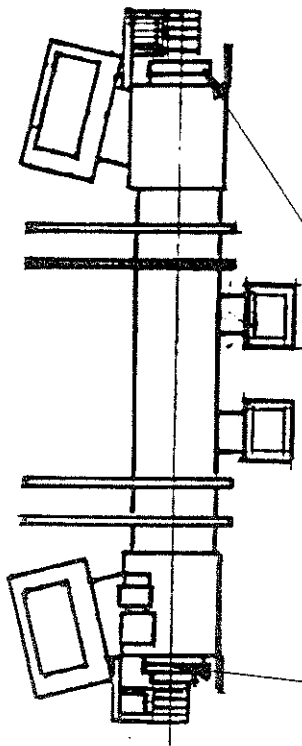
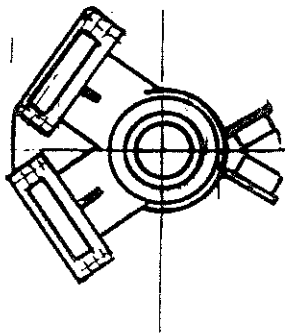
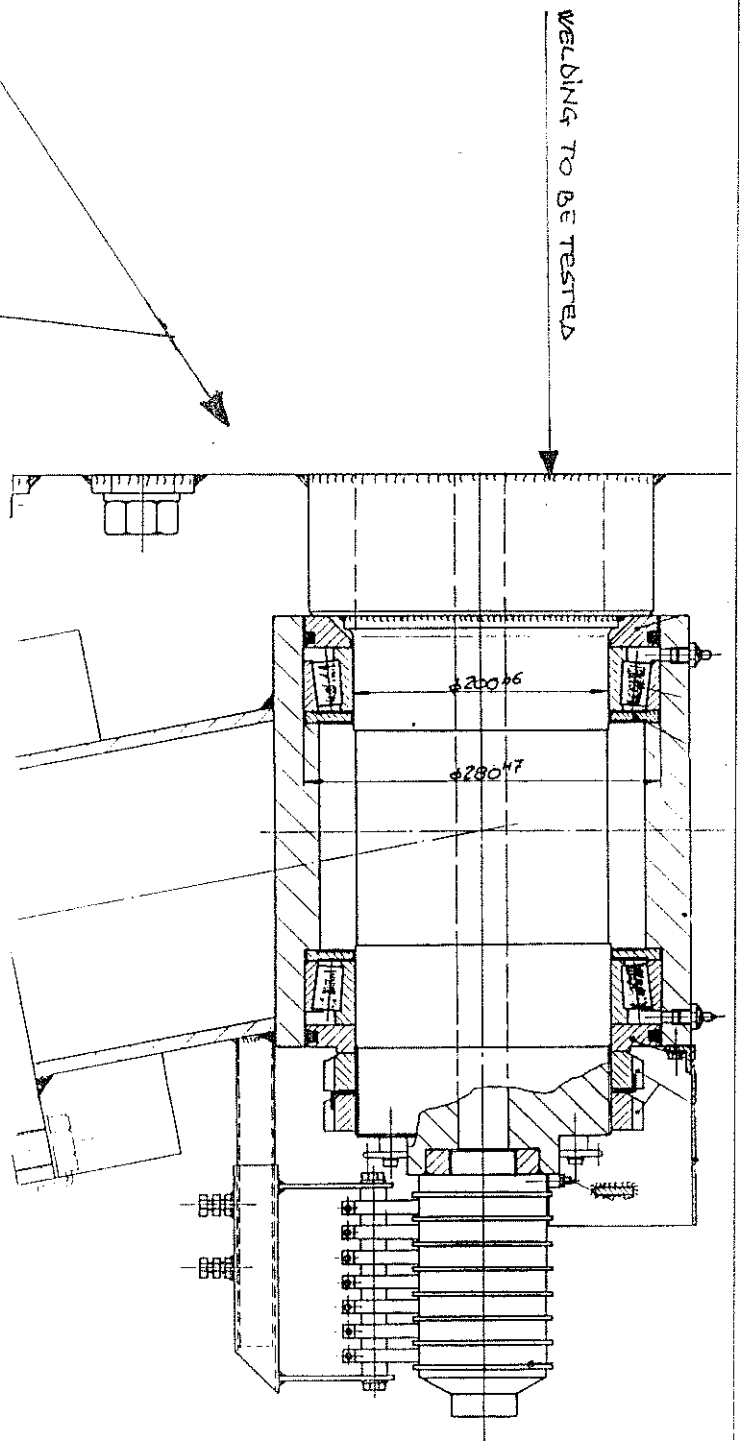
Some cracks have been occurred and noticed on the welding of both side of the a.m. shaft . (see enclosed to localize the area)

Any kind of crack, on the welding material, doesn't affect the performances and the safety of the ride.

A carefull inspection is recommended to the Galleon ride owners, in order to verify the condition of the weldings, this inspection has to be performed every two operational seasons, at least.

1. Verify, with a first visual control, the superficial conditions of the weldings. If some crack is in process, it can be noticed on the enamel coating surface.

2. Perform a non-destructive test by a magnetic crack detector or by penetrant liquid inspection, in the second case the enamel coating must be removed, in order to have the cracked area completely cleaned.

3. If crack has observed, remove the shaft and proceed to disassemble it. Consult our assembly drawing no. 9.207.020.001A, for your reference.
4. Grind the cracked area in order to completely remove the crack. The correct removal of the crack, will avoid the beginning of rust process.

5. Verify again, by magnetic crack test or penetrant liquid inspection, if the crack was completely removed.
6. Pre-heat the area at a temperature of 200°C.

7. Make a new welding following the instruction contained on our drawing no. 9.229.020.003A.
8. Cover the rewelded area with insulating material, in order to get a slow cooling of the repaired area

9. Grind a little the new welding, in order to remove some possible roughness.
10. Repeat again the non-destructive test in order to verify the quality of the job performed.
