NAFLIC

TECHNICAL BULLETIN — October 2015

398. SBF Frog defect

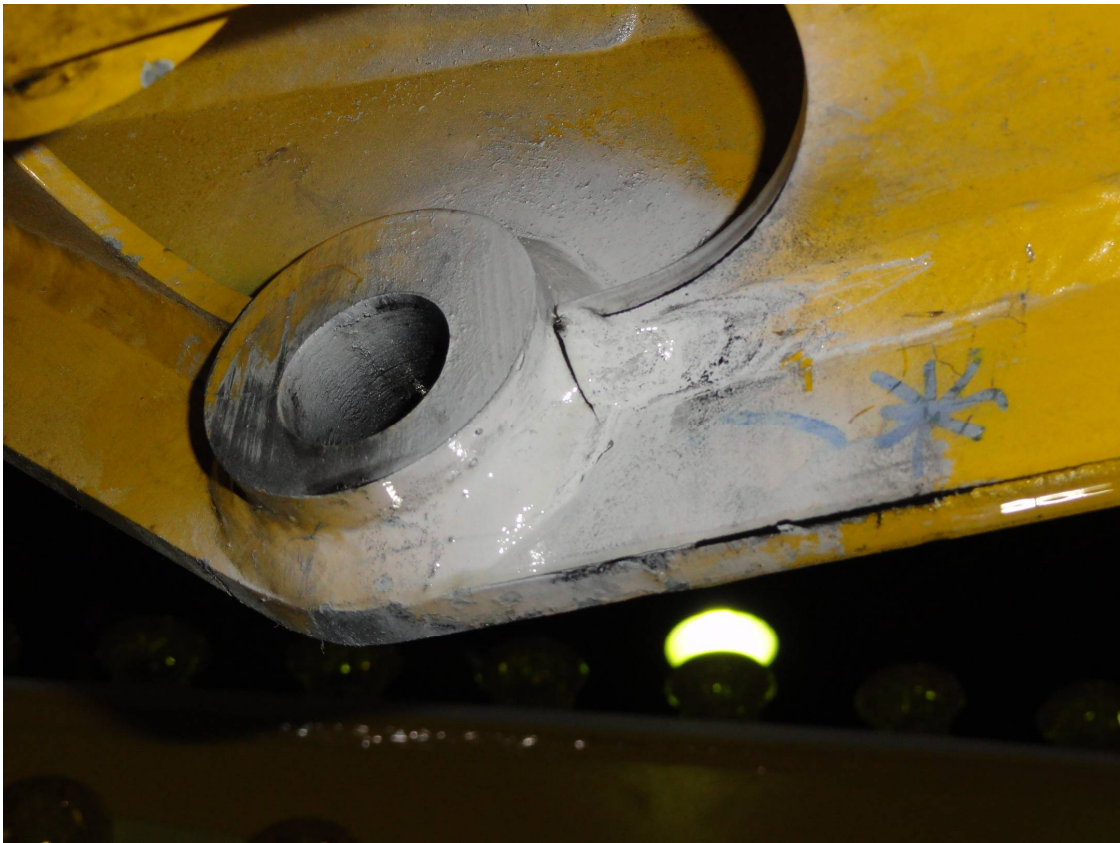
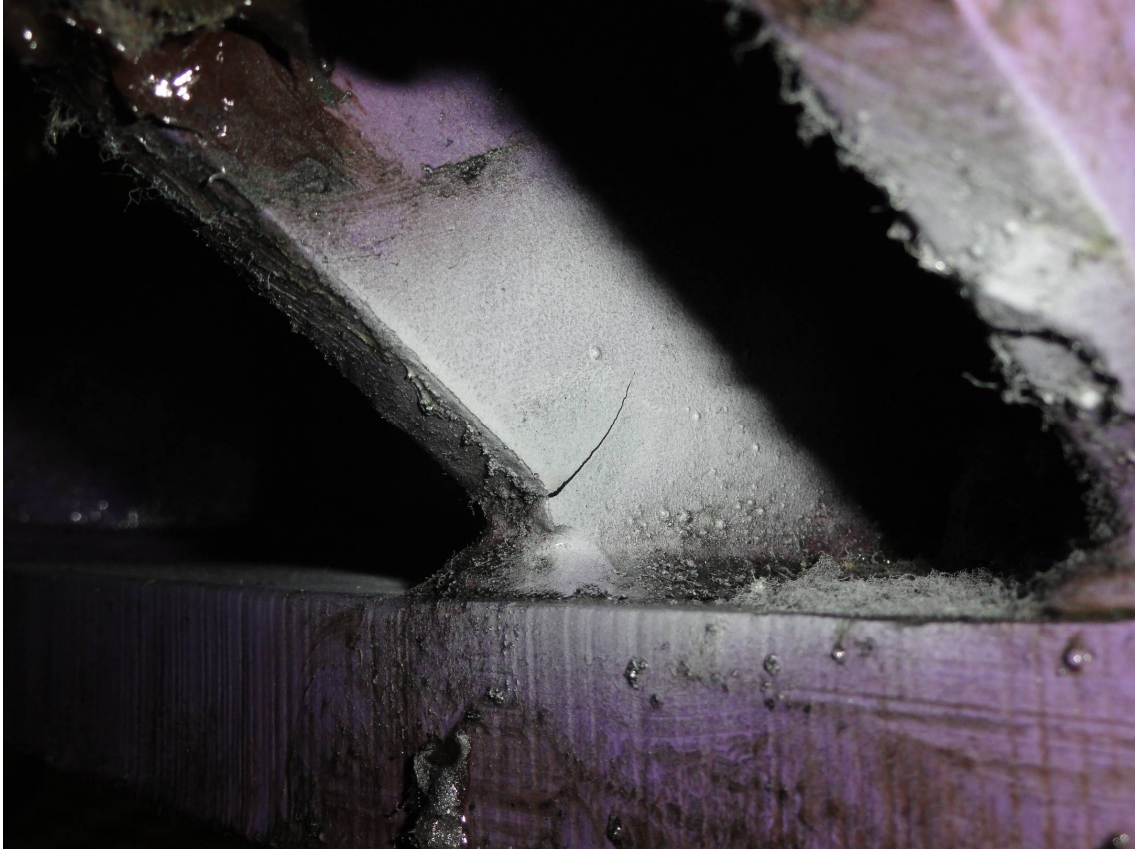
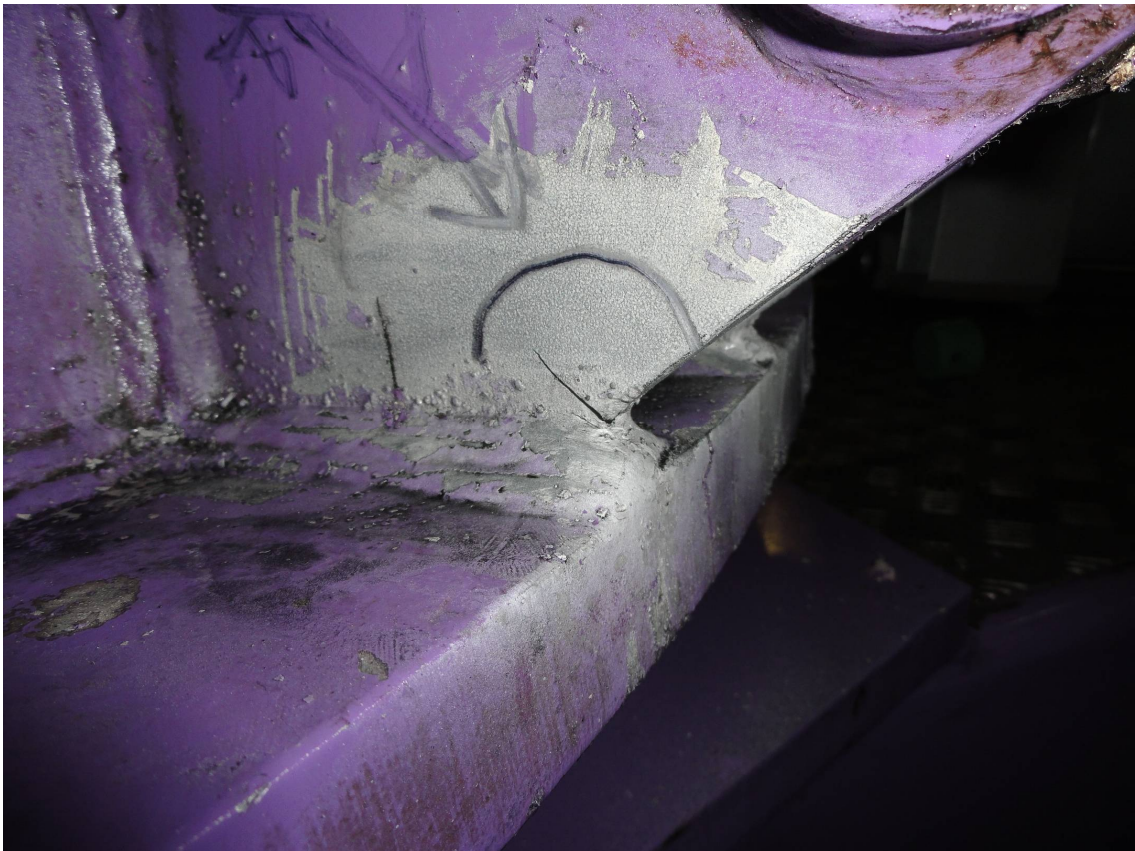
A defect has been identified on an SBF frog manufactured in 2003. A crack has propagated from the toe of the weld at both the attachment point for the top and bottom of the rams that cause the bouncing motion (see accompanying photos).
