Nottingham UK Miami - corrosion to over the shoulder passenger restraints

Date; 10-3-2016

Device; Miami – notts uk – year of manufacture 2009.

Scope of report; Annual inspection.

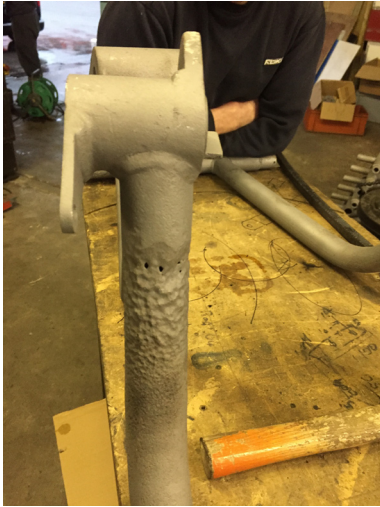
1. As part of the annual inspection, surface corrosion was noted at the hinge / tube connection point of the overhead restraint bars, the device has 16x single overhead units, the outer polyurethane (padding) covering was removed from 2x safety bars as a percentage strip down, the results can be seen from the 2x attached pictures, there is no documented history of this level of stripdown being carried out on this device- as such we shall assume this is a progressive corrosion over the life of the device – the padding once removed was found to have degraded and as such water and moisture was trapped – sponge like against the steel work.

1) Miami; overhead lap bar stripped down – padding removed.

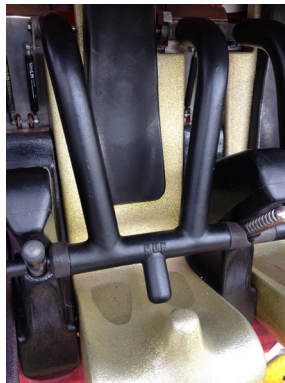
3) Showing new safety restraint bars fitted.

2. The remaining units were stripped down and 14 out of 16 were found to be in varying stages of extreme corrosion.
3. The manufacture has supplied 16x new units of which the steel work is galvanised.
