431.

Huss Top Spin main tower mast cracking

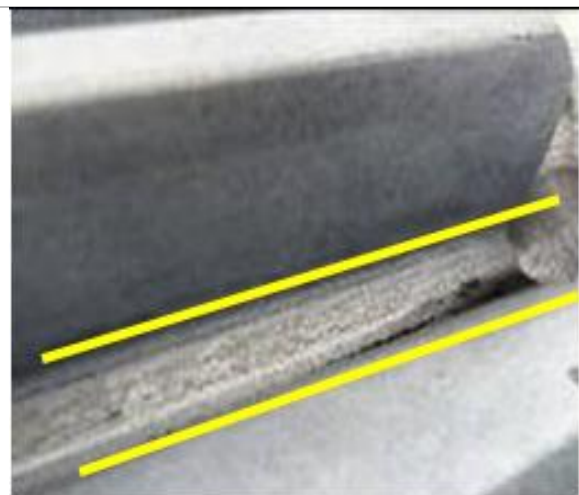
Figure 6: Pinion cracking
