436.

## Afterburner fatal accident - update

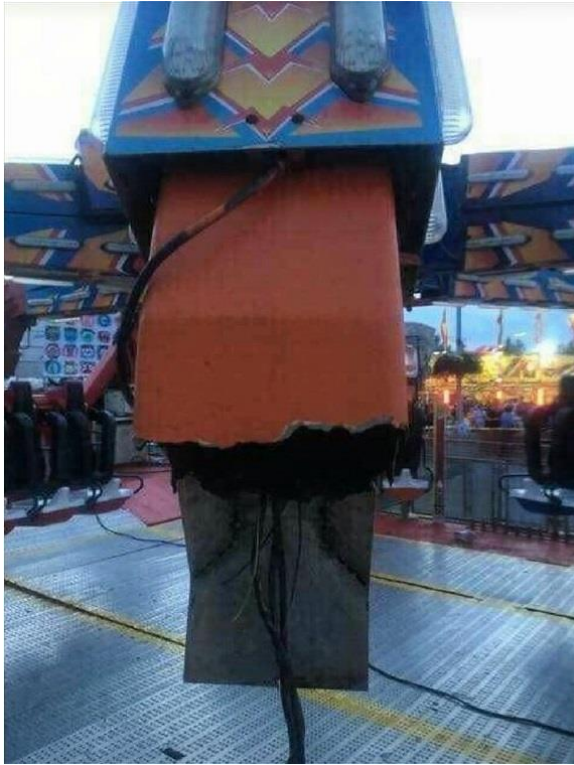
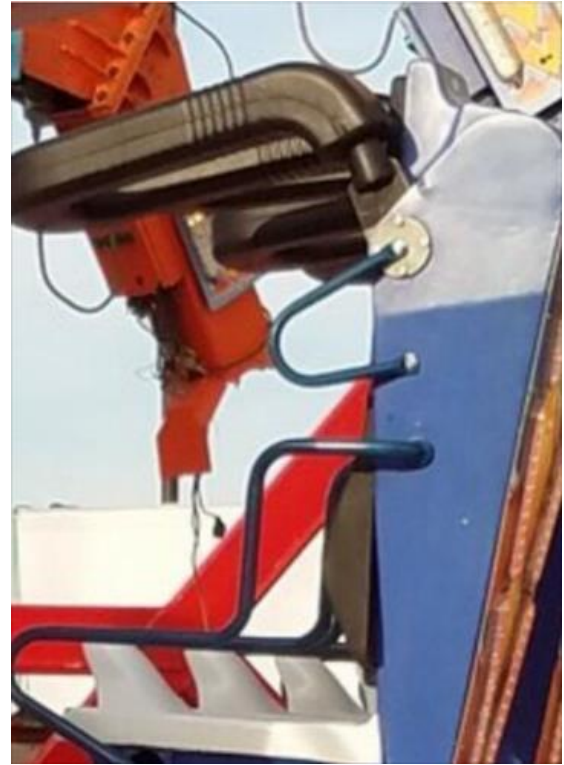
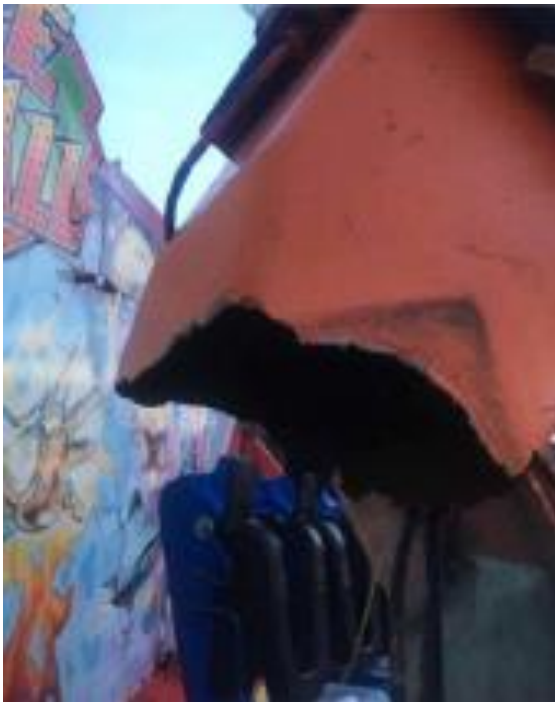
It is advised the structure appears to have failed between the sweep arm and the gondola and not at the bolted connection as was originally thought, see attached photos. It is understood from the HSE that the structure had suffered corrosion which had reduced the material thickness. It is further understood that an ingress of water occurs during the transport and storage that leads to the corrosion. It is understood that KMG, the manufacturers of these devices, has written to owner/operators and instructed that the machines are not used until the cause is fully understood.

Any IB's that are asked by the owner/operators to undertake an inspection of these devices should arrange to inspect the inside of the affected structure. They should also undertake a detailed thickness check on the material, over the complete section and record the results. It will then be for the manufacturer to provide advice on what the acceptable level of loss of material is, if any at all.

Thereafter, it is expected that the NDT schedule will have to be revised.
