445.

## Edwin Hall Twist

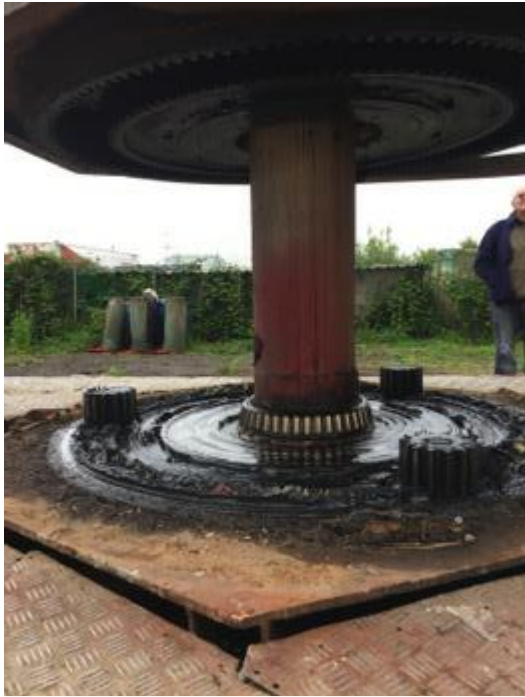
The centre needs to be removed to gain access to the brake pinion bolts.

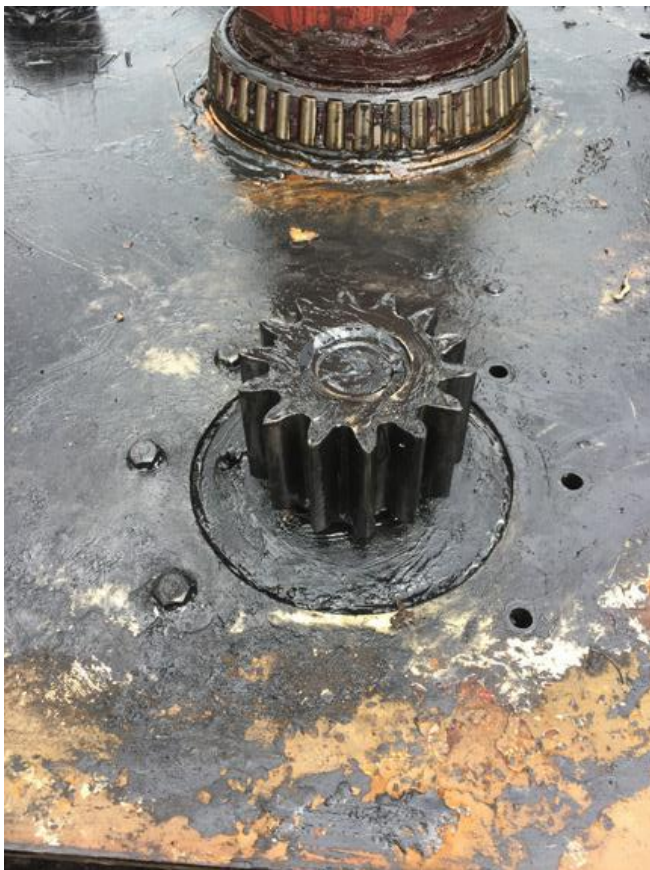
As the pinions are meshed with both an inner and outer toothed ring, failure of the pinion mounting can cause it to move and jam the ride. Should this happen when the ride is at full speed the potential sudden stop could cause severe structural damage to the ride and impact injures to the public.

The missing bolts that have sheared on the brake pinions.

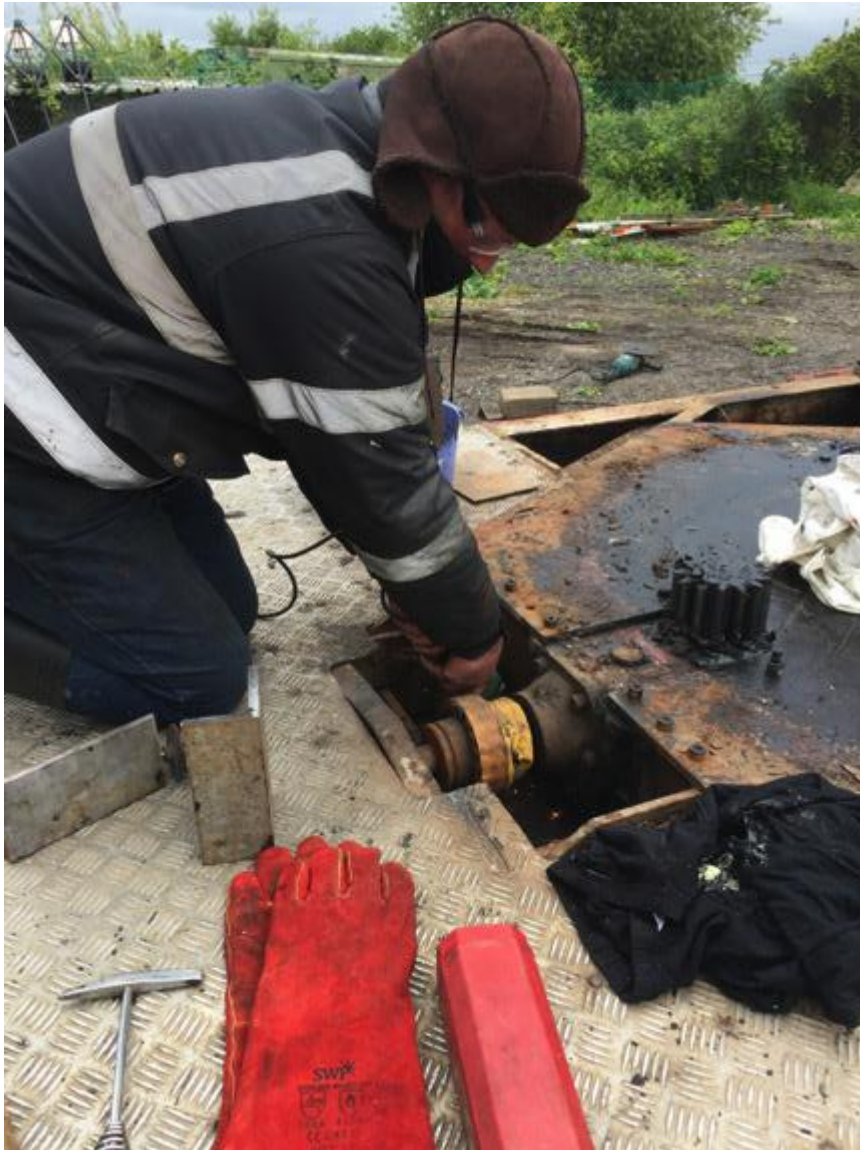
Above can be seen the six Allan key studs securing the gearbox and drive pinion. They had all sheared and could be lifted out by hand.
