## 450.

# Climbing wall hydraulic cylinder failure

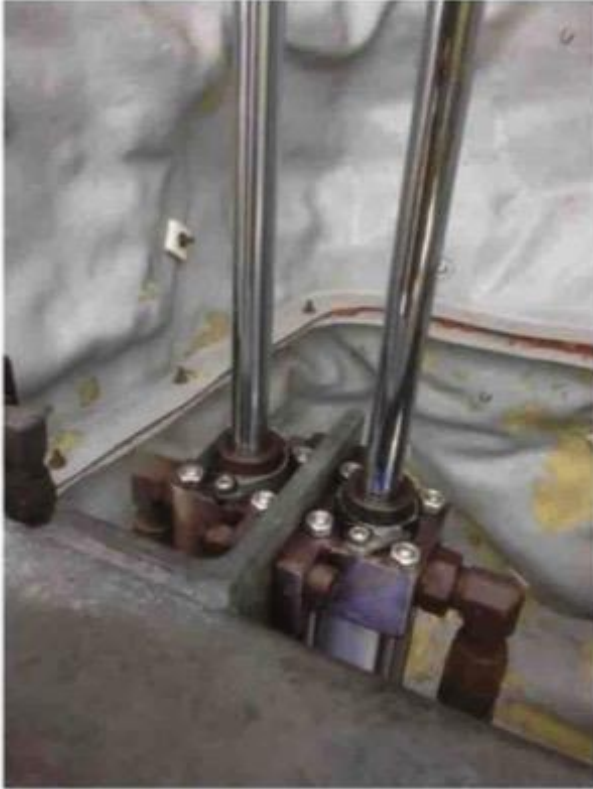
The image above shows the double cylinder set-up on the belay system and the two retaining caps secured by Alan key studs.

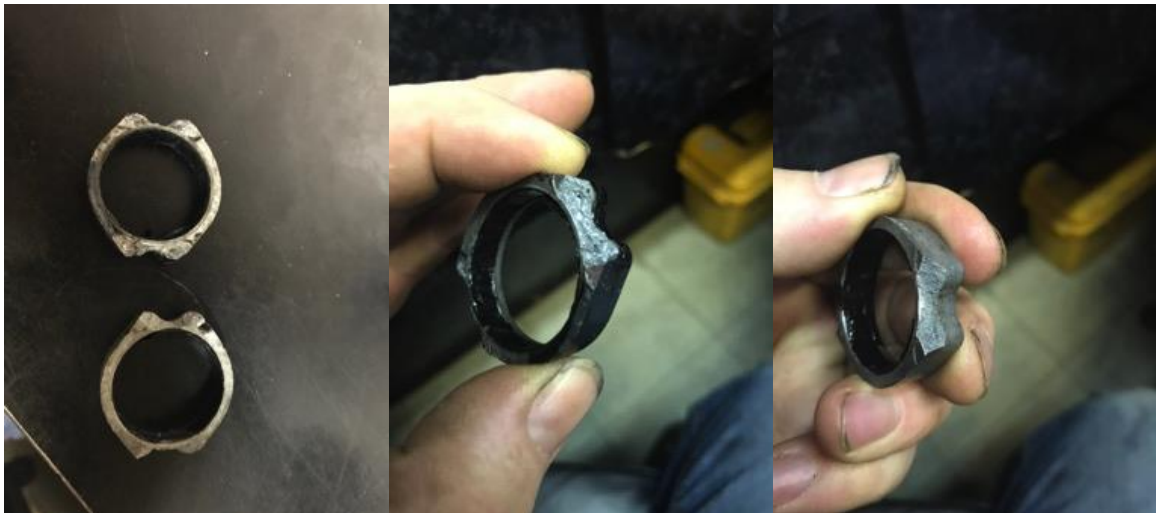
Cast components are known to be brittle and whether this was the cause of this particular failure is unknown.

The above images show the two failed seal retaining caps. Both have had their bolting lugs sheared completely off.

- Operators should be aware that there is a maximum weight limit for these devices of 250lb (17.85 stone, 113.4Kg) (taken from the manual).
- Operators should carefully check the retaining cap every time they change the shaft seals and ensure they do not over tighten the cap screws as this could over stress or damage the cap.
- Daily checks of the hydraulic system may reveal leaking at the shafts. Operators should remember that this leaking may not be shaft seal wear but may be a sign of shaft seal cap failure.
