458.

Intamin raft boat lifting bolt failure

NAFLIC has received a report from a UK registered inspection body of several failures of the lift eyelet bolt and the raft GRP on an Intamin raft boat.

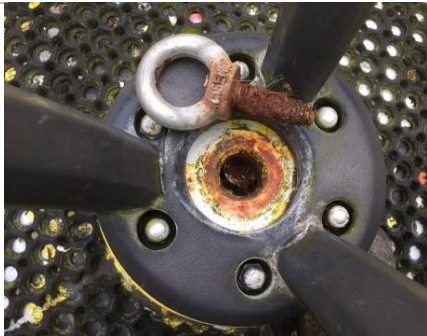
Figure 1

1. The lift eyelet bolt and its threaded connection point had suffered from corrosion and sheared during lifting operations (figure 1).
2. The raft GRP around the lifting eye had suffered from UV degradation with the eyelet assembly detaching from the boat's GRP.

Given the nature of use and level of strip required to access these components, it may be possible to risk assess and mitigate the risk of failure through the implementation of safe alternative lifting and transportation practices. Known examples include the use of boat lifting frames (figure 2 shows an example), ground transportation via crate rather than suspension and limiting the use of existing lifting eyes to only lift boats clear of the floor.
