460.

Zierer Hornet coaster brake/drive beam failure

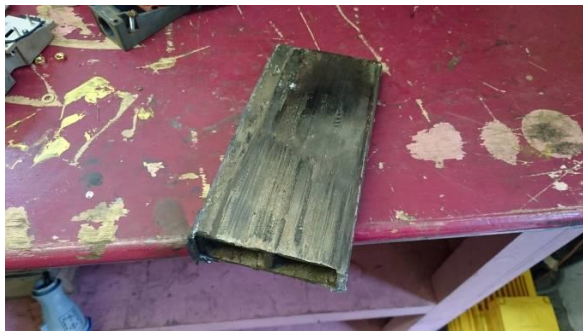
Fig. 1

A UK registered inspection body has reported defects on a Zierer Hornet roller coaster. A section of the brake/drive fin became detached from the ride (this type of brake fin is also found on other types of Zierer coaster).

On further inspection, the section of brake/drive fin that was ejected from the device was found to be from a join in the fin approximately 200mm away from the front of the leading edge. The joint consists of a 3mm plate welded to the end of the box section/brake fin (Fig. 2) with the tapered end piece welded to that to make up the lead into the drive tyres and brakes.

The manufacturer should be contacted for WPS and thickness specifications.

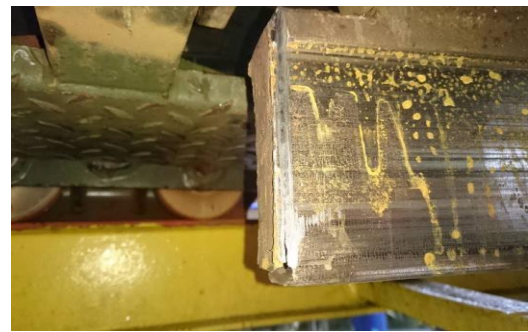
Fig. 2

The welded joint appears to have been full thickness, welded top and bottom but with only a shallow run up either side. These side welds have, over the years, been worn away due to the friction action of the brakes and drive tyres, meaning that the front tapered sections were only held on by the welds top and bottom.
