NUMBER: B391R1018-0

SERVICE BULLETIN

Ride: FALLING STAR

Subject: Inspection Of Vehicle
Mounting Plate

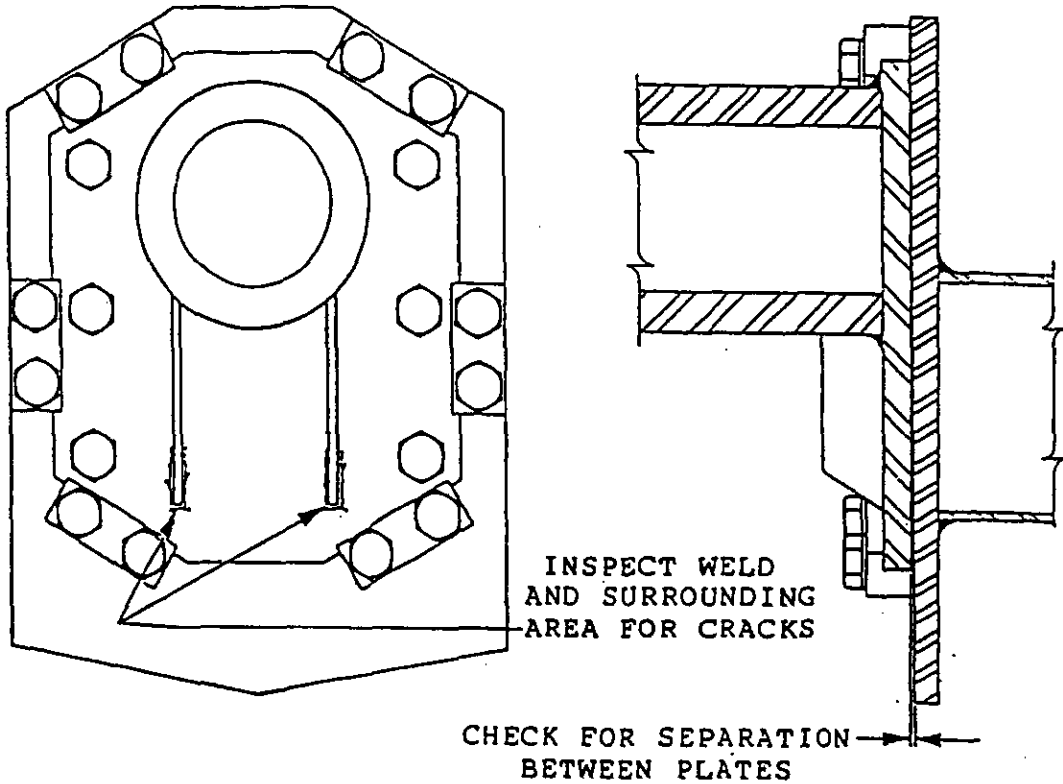
th the vehicle installed on the sweeps and the capscrews tightened to 700-840 ft-lb., inspect the front stub shaft as shown in the illustration below.

Inspect the weld and the parent metal surrounding the weld. Also, make sure there is no separation between the two plates as shown.

If cracks, separation or any unusual condition exist, contact the CHANCE CUSTOMER SERVICE DEPARTMENT immediately. DO NOT OPERATE THE RIDE.

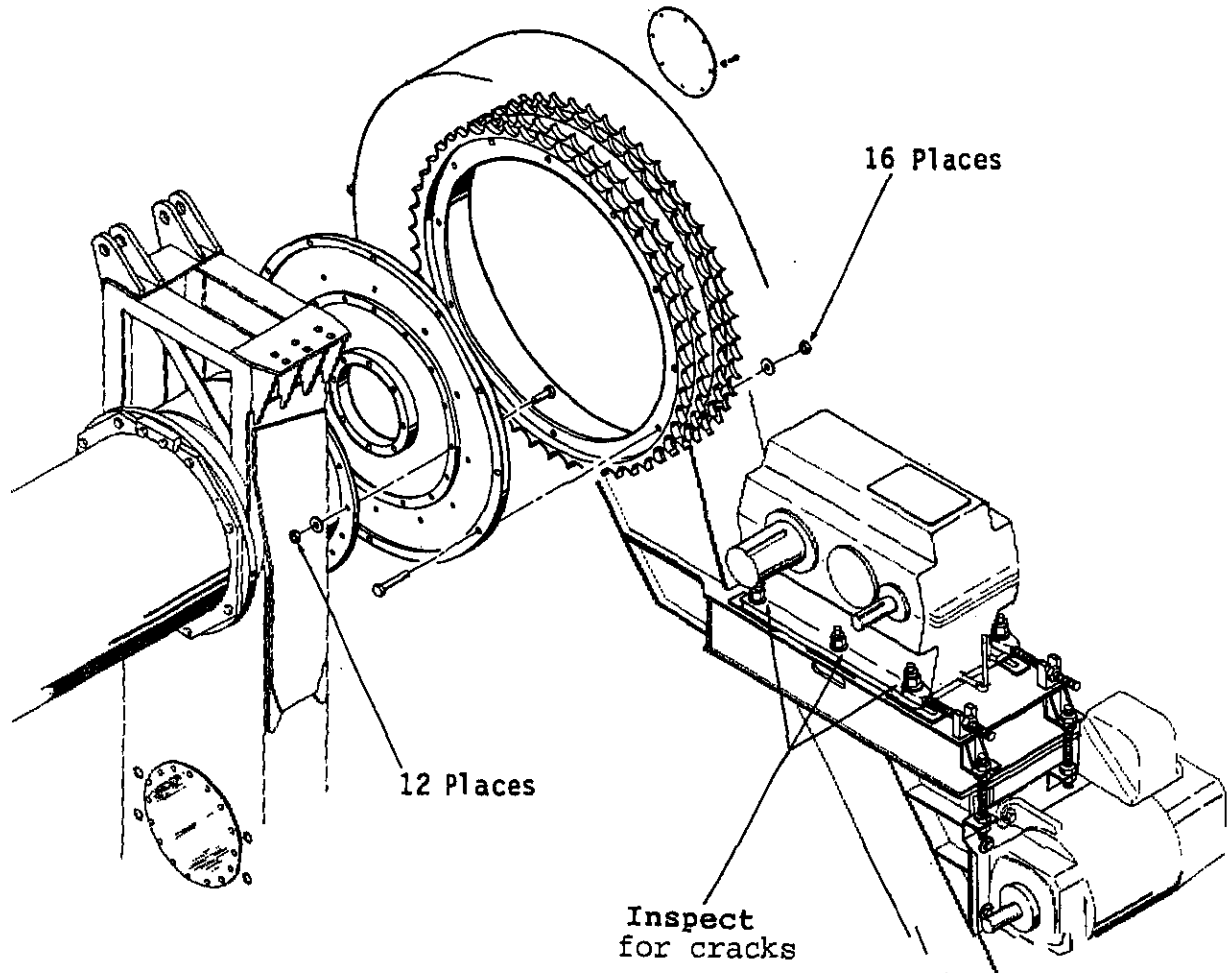
1. Use a torque wrench to check the tightness of ALL fasteners indicated in the illustration below. The correct torque of the fasteners must be 760 ft-lb if checked at the nut, or 840 ft-lb if checked at the capscrew head.

2. Inspect the base plate of the gearbox for cracks in the area around the attaching capscrews.

If loose fasteners, cracks or any unusual condition exists, contact the CHANCE CUSTOMER SERVICE DEPARTMENT immediately.

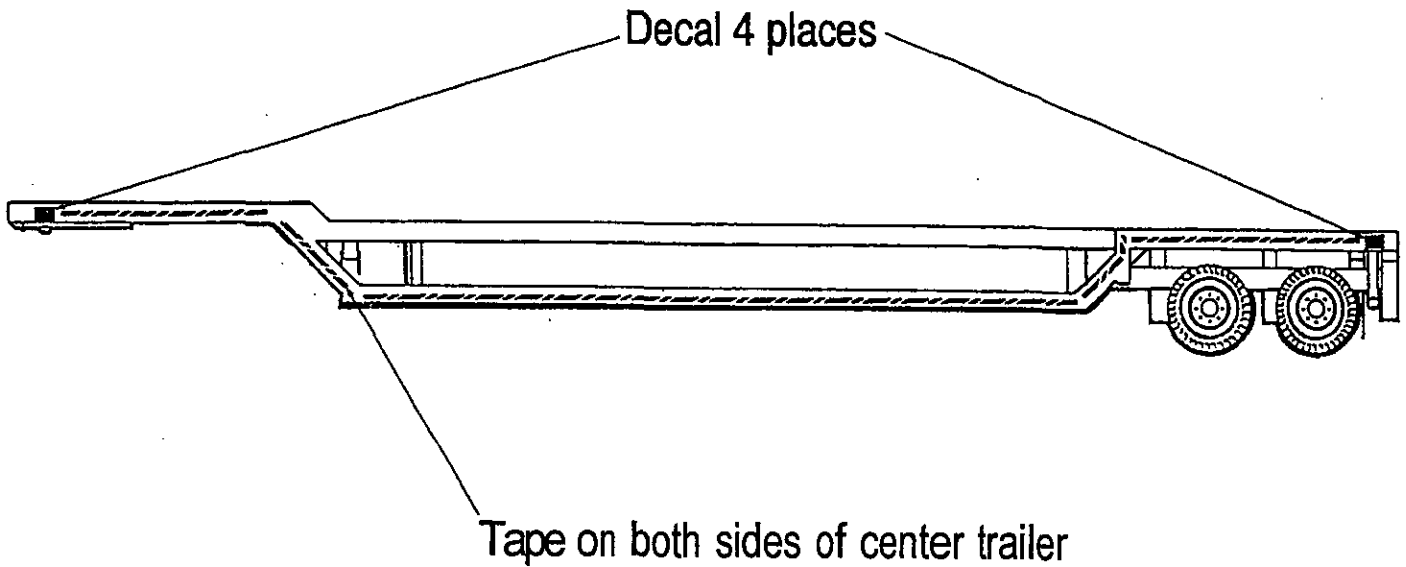
1. Apply one decal (item #1) to each of the four inside corners of the center trailer.
2. Apply tape (item #2) to both sides of the center trailer at areas where trailers come together.
