TECHNICAL BULLETIN — October 2015

400. Hydraulic cylinder problems

Issuing Entity:	Bulletin No.: SB-033_01
Vekoma Rides Parts & Services B.V.	Release Date: 19-03-2015
Schaapweg 18	Effective Date: immediately
6063 BA VLODRUP	Supersedes: N.A.
The Netherlands	Completion Date: within 4 weeks fter release of this Bulletin
CoC Number: 12049585

Service Bulletin

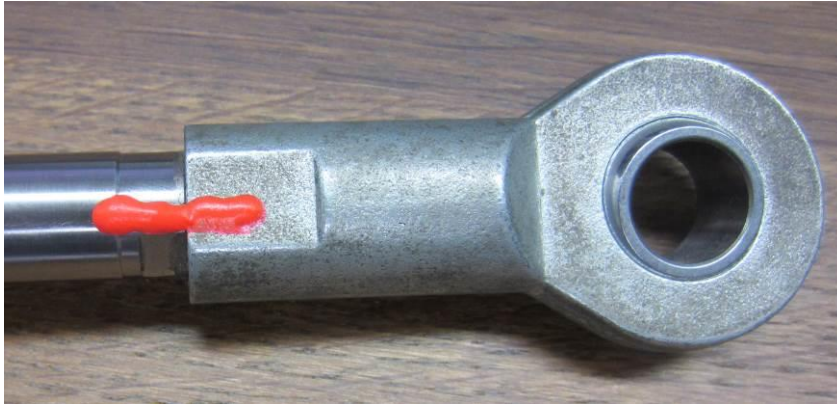
Figure 1: how to apply torque striping on the rod end.

Issue	: In the past the Supplier could not guarantee that the piston rod could not come loose at the joint head.
Action Supplier	: With the newly delivered HLU’s, the production process was changed by adding Loctite 243, a locknut and torque striping. This way they are able to guarantee that the piston rod can not come loose at the joint head.
VRP&S’ advice	: Add torque striping to the piston rod at the joint head (see figure 1) and perform a weekly check on this area. HLU’s that are not installed yet (such as spare cylinders) need to be checked for Loctite 243 before installation. See the remarks next to Table 2 for the correct torque values of the rod ends for both the LE 25 and LE 32 units.

Apply Loctite 270 and torque striping. In case no locknut is applied, the torque values for the LE 25 and LE 32 unit are respectively 25 ±5Nm and 30 +5Nm.

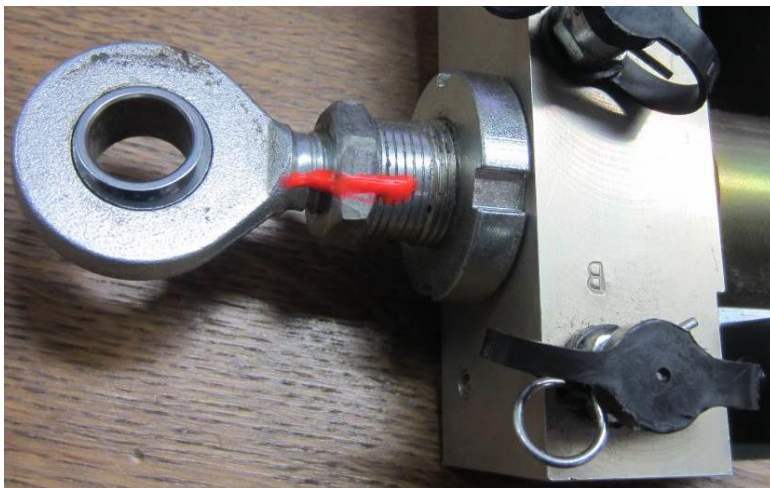
Figure 2: how to apply torque striping on the threaded screw assembly at the bottom.

- Issue : The supplier added an additional requirement on the length of the threaded screw assembly. Due to the adjustment function of this connection it is not guaranteed that the threaded screw assembly is within the specified range.
- Action VRP&S' : Checking this connection was included during installation of the HLU in the vehicle.
- VRP&S' advice : Check the length of the threaded screw assembly. If applicable it needs to be corrected. For the correct settings, please refer to the text below for the LE32 units and table 2 for the LE25 units (these values are created from the Supplier's document). Add torque striping to the connection (see figure 2) and perform a weekly check on this area.

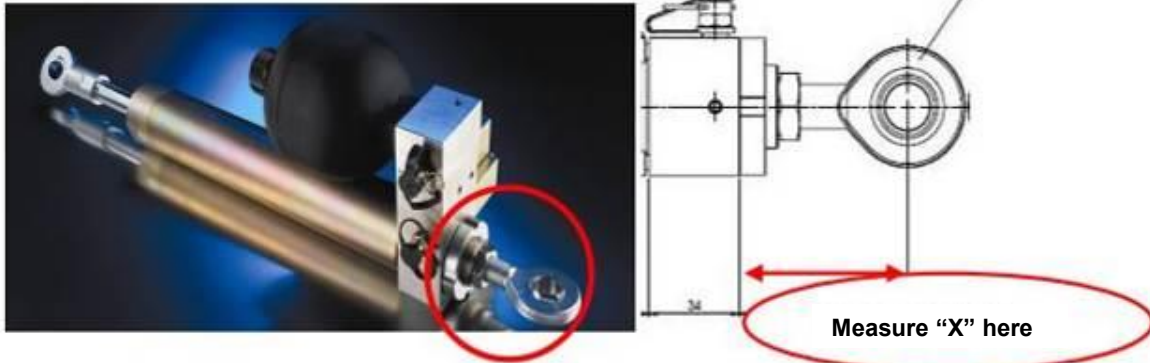
Figure 3: information for LE32 and LE25 screw connection at the bottom.

For the LE 32 versions the screw thread depth is correct when the rod end length “X” is below 65 mm. ($X < 65\text{mm}$)

For the LE 25 versions the screw thread depth is correct if the rod end length “X” is below the value as stated behind the product number in de table below. The small x at the end of the product number indicates the version number.

We recommend that the joint rod heads be secured at the specified dimensions and tightened with a torque wrench. The LE 25 version should be tightened to **80 Nm ±10 Nm**. The LE 32 version should be tightened to **90 Nm ±10 Nm**.

The correct measurement must be set and checked when installing or performing maintenance on the Cylinder Accumulator unit. In this way the required minimum screw thread depth engagement (as set out in VDI 2230) is maintained.

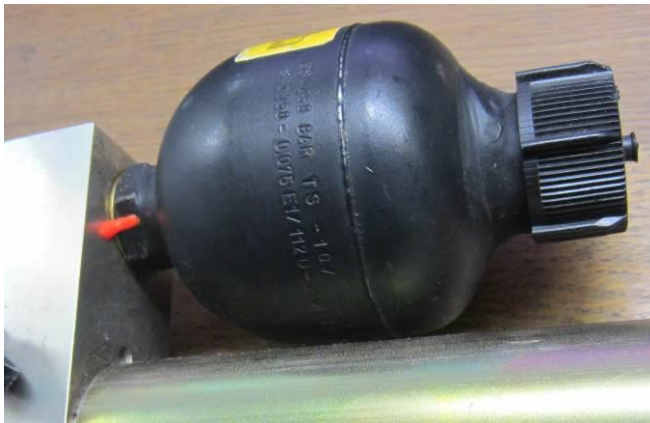
Figure 4: how to apply torque striping on the accumulator.

- Issue** : After reviewing all connections and the Hoerbiger safety related document, below actions are taken to reduce the risk of a loosening accumulator.
- Action Supplier** : Checking the accumulator connection was included in the assembly process.
- VRP&S' advice** : Add torque striping between the connection of the accumulator and the manifold block (see figure 4) and perform a weekly check on this section.

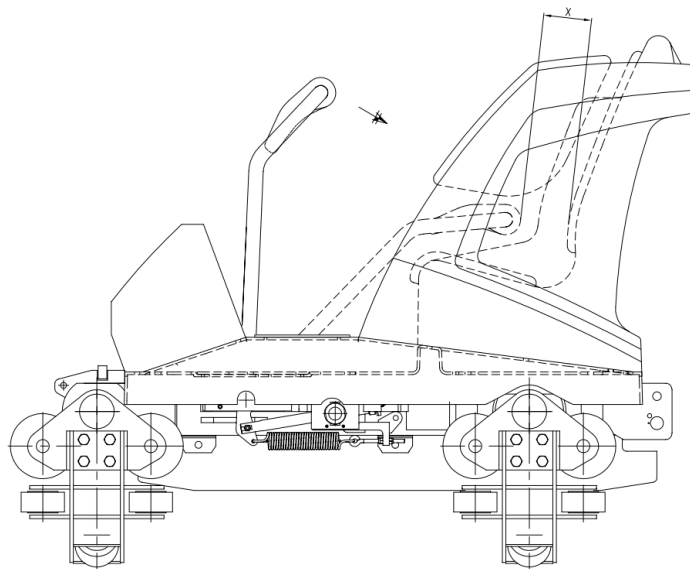
This example image is for reference of dimension X only.

1. Close the restraint, make sure the right hand side HLU is only locking the restraint;
2. Measure the minimal distance (X) between the restraint and the seat (only at start of test);
3. Log this dimension for every seat (only at start of the test);
4. Wait for 10 seconds;
5. Measure the minimal distance (X) between the restraint and the seat;
6. In case this dimension increased by 2 cm the HLU failed and needs to be replaced immediately by a HLU which passed the 1050 cycles;
7. If no dimension change was noticed proceed with step 1;
8. Keep repeating this procedure until 200 cycles have passed the test procedure;
9. Repeat this test and make sure the left hand side HLU is only locking the restraint;
10. After completion of the 200 cycle test for the left and the right HLU it is allowed to take the vehicle in operation.

1. Close the restraint
2. Measure the minimal distance (X) between the restraint and the seat (only at start of test);
3. Log this dimension for every seat (only at start of the test);
4. Wait for 10 seconds;
5. Measure the minimal distance (X) between the restraint and the seat;
6. In case this dimension increased by 2 cm the HLU failed and needs to be replaced immediately by a HLU which passed the 1050 cycles;
7. If no dimension change was noticed proceed with step 1;
8. Keep repeating this procedure until 200 cycles have passed the test procedure;
9. After completion of the 200 cycle test for the single HLU it is allowed to take the vehicle in operation.

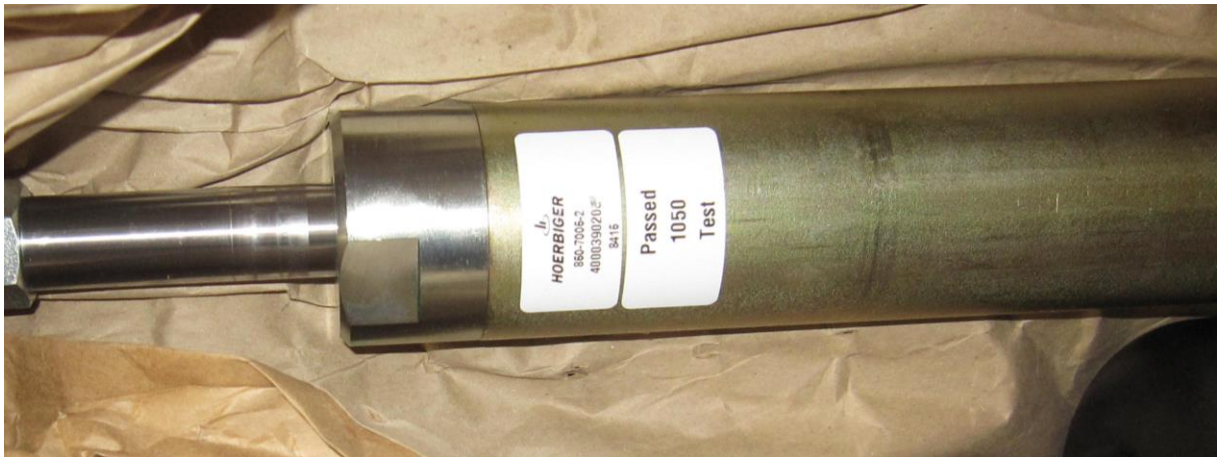
The picture below shows the correct indication that the HLU has passed the 1050 Cycle test.

All HLU's, at the customer warehouse should be checked if they are labelled with "passed 1050 cycle test". If this is not the case, contact VRP&S to make sure the HLU's will be tested prior to assembly into a vehicle.
