404.

GERSTLAUER EUROFIGHTER

Train chassis cracking and seat post cracking

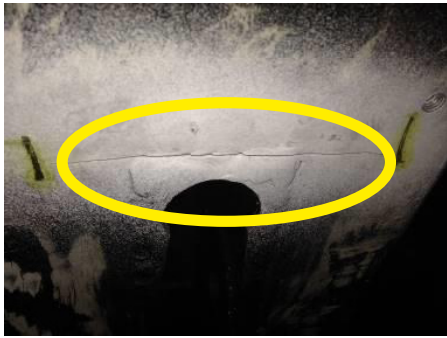
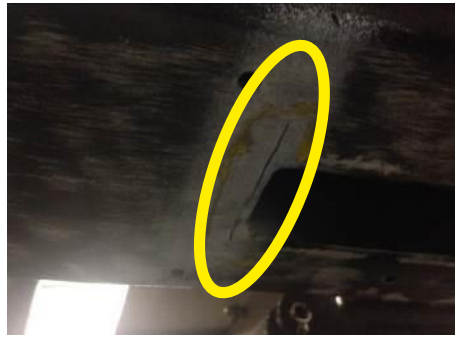
These trains are used on a number of different track configurations. This particular one has a number of indications of cracks but the majority of these are hidden under drive plate materials. The extent of the cracks can therefore only be fully seen when the drive plate is removed. This may not be included in the normal NDT schedule so IBs are recommended to pay attention to all areas relating to this.

▲ Drive plate area

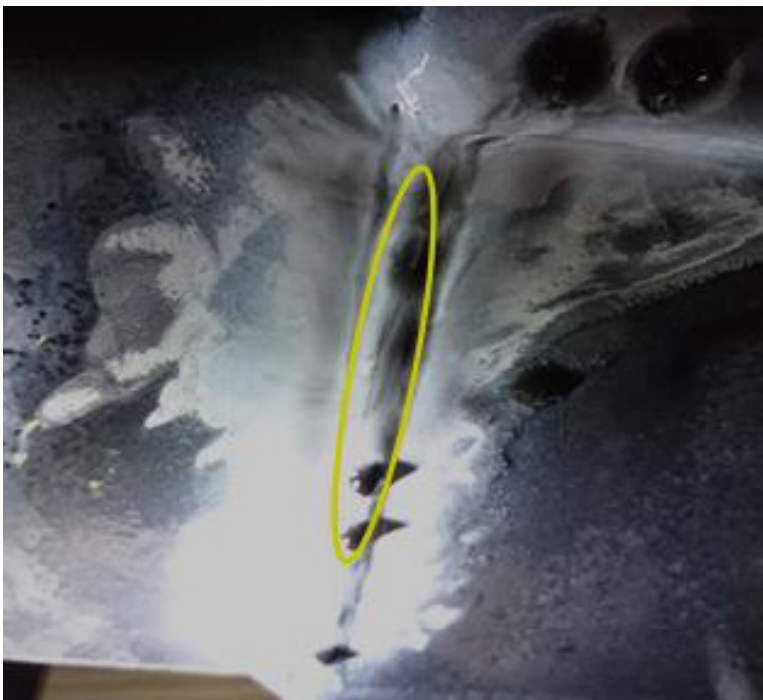
Additionally, again in relation to a Gerstlauer EuroFighter, the same IB has found an area of cracking next to where the magnetic brake is fixed to the chassis (see images). To fully inspect the area by MPI the magnetic brake requires removal.

▼ An area of cracking was found next to where the magnetic brake is fixed to the chassis (see following three images)

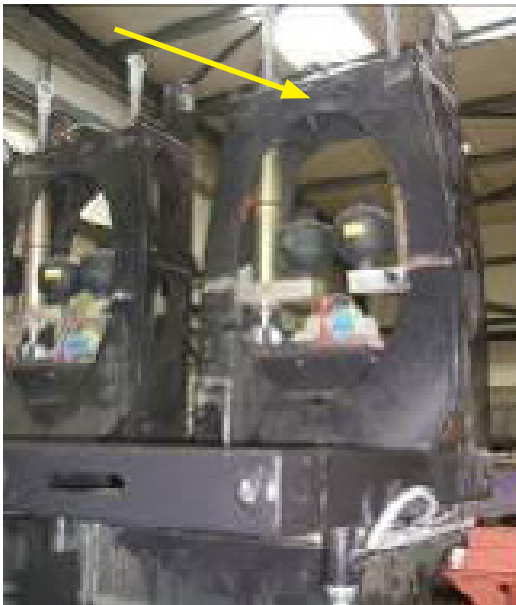
Seat Post Cracking

Also in relation to a Gerstlauer EuroFighter, we have received a report from the same IB that areas of cracking have been found on the top of numerous seat posts. These were found by both visual and NDE inspection. The manufacturer has issued a WPS.
