405. Intamin Drop Tower seat bracket cracking

We have received a report from a UK registered inspection body that numerous areas of cracking have been found on the seat brackets on an Intamin Drop Tower ride. These areas of cracking were found by Visual Examination and Dye Penetrant Testing and are in unexpected areas.

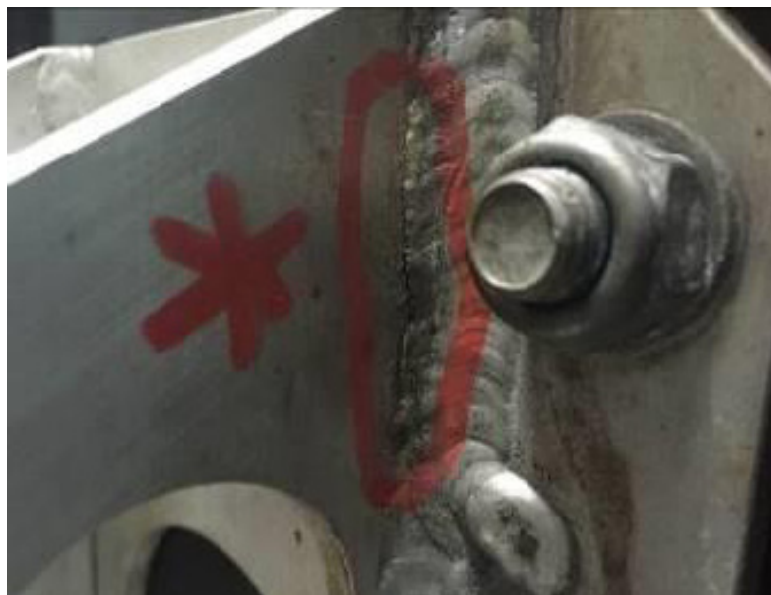
▲ Cracking on a vertical weld – found by DPI
