421.

Ghost Train hair entanglement

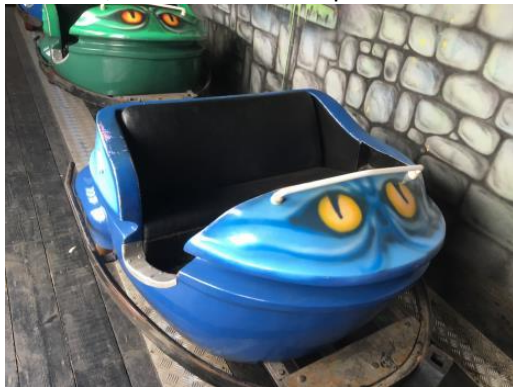
Figure 1

We have received a report from a UK registered inspection body of a hair entanglement point on a Ghost Train drive system. The occupant's hair has fallen through a small gap between the side of the GRP body and the rear seat padding. The ride is approximately 30 years old.

NAFLIC would remind controllers that this is a good example of a 'no gap is too small' situation and that even the smallest of gaps on passenger vehicles can potentially be a hazard risk. Our advice would be to ensure such gaps are covered or enclosed in some way if possible and that adequate safety signage is in place advising guests to tie back long hair and remove any long flowing items such as scarves, etc. Also, ensure that ride operators are trained to enforce these rules.

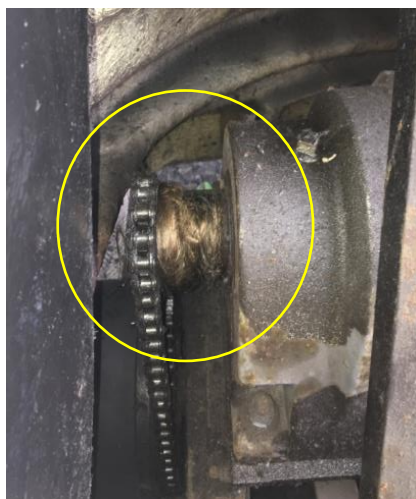
Figure 3 – hair entanglement point

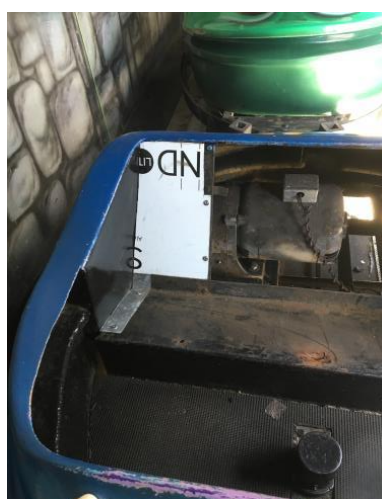
Figure 4 – additional cover to prevent hair entanglement on the drive system
