## Vekoma Boomerang coaster car axle cracking

**SAFETY ALERT MESSAGE**

**Reference : P&S/CPE/0408.1707**  
**ISBN : 11111**

# Service Bulletin

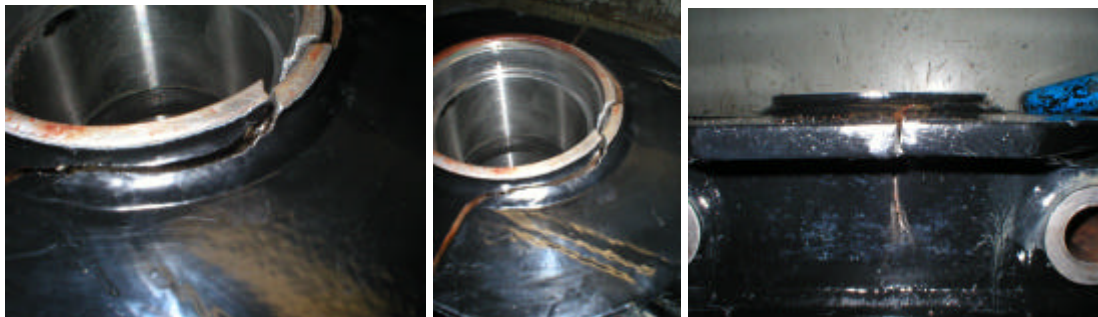
During the ride a strange noise was heard. Inspection immediately after the ride learned that one main axle was broken during or just before start of the ride. No passengers were hurt due to this incident.

See pictures below:

The line of the break originated from a crack in the center of the main axle. This crack, due to fatigue and, based on the rust patterns, was already in place for a considerable amount of time. The owner has applied powder paint to preserve the main axle. As a result of this flexible paint cracks could not be discovered in an early stage.

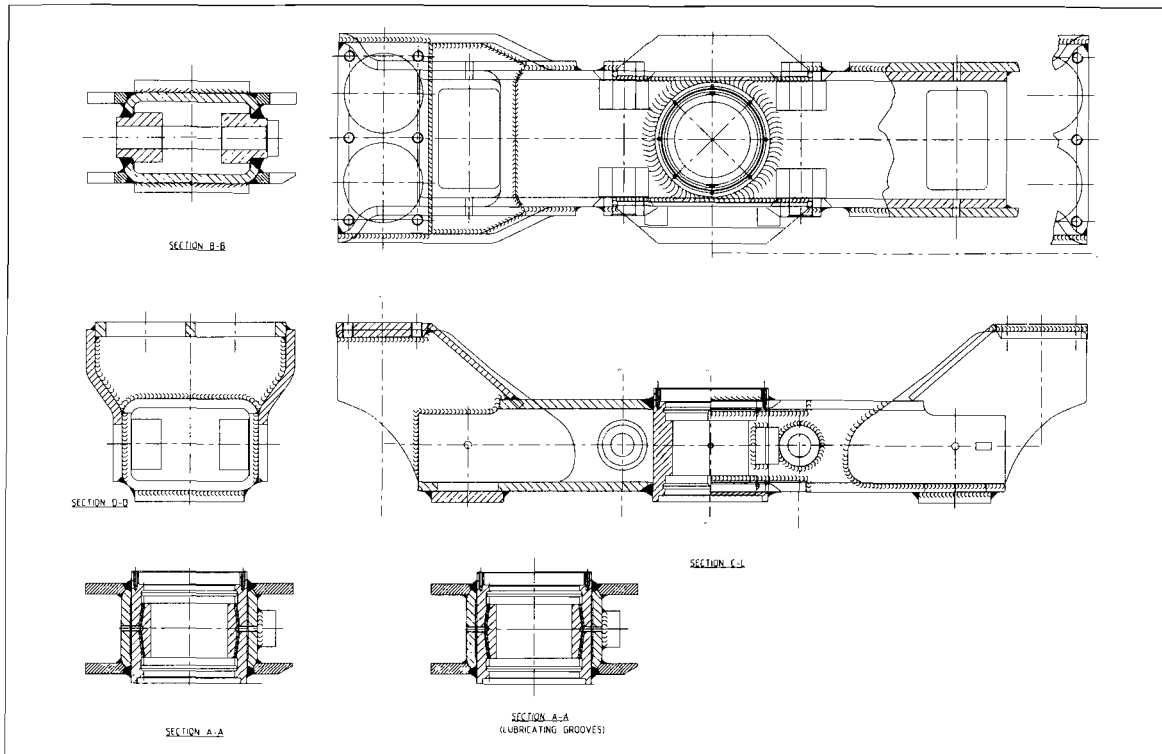
figure 1: Welded joints to be checked

- 1 Visually inspect all welds of the axle.

- 1 Check **all welds** of all main axles and rear axle for indications of cracks.
