Safety Alert – Hill/Valley ‘Tram’ based rides

Background & Scope

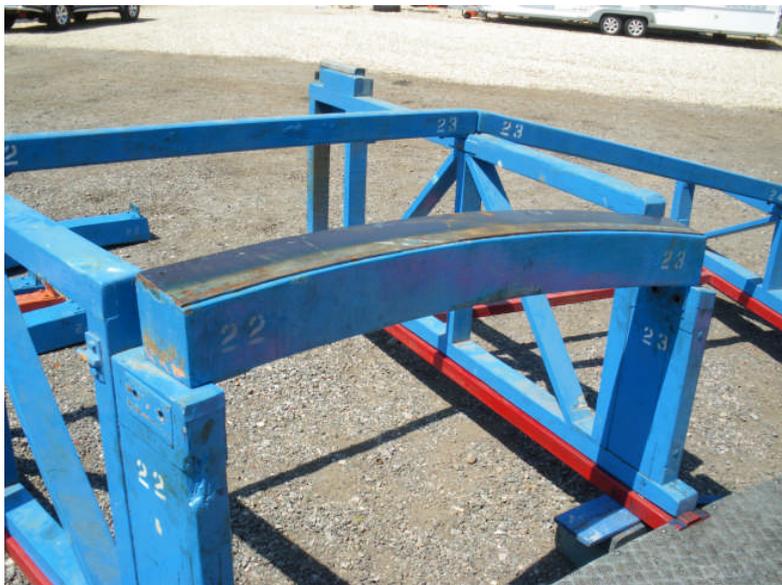
Fig 1

This alert refers specifically to those rides with a metal tram top running on a wooden frame. An example of a section of such a tram is shown at Fig 1:

Ride controllers should conduct a thorough visual check of the condition of both the metal rail and the supporting woodwork to ensure there are no obvious signs of any deformation or rot around new or old fixings. Particular attention should be paid to areas where repairs have been made. Any future repairs to the tram, a safety critical part, should be discussed with your ride examiner and a design review conducted.

Ride examiners should, when conducting the normal annual inspection, thoroughly check the entire tram for structural integrity, paying particular attention to areas where repairs have been conducted, to ensure decay is not propagating from old fixings. Any tram repairs should be treated as repairs to safety critical components and reviewed as such.

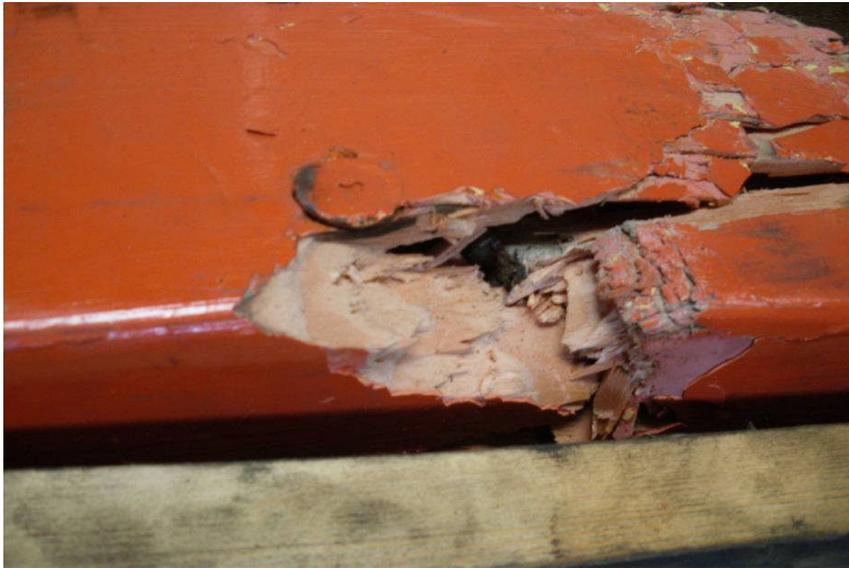
Whilst investigations are ongoing, initial investigations suggest that the failure may have occurred close to a site of a previous repair where a redundant bolt had not been removed. It is possible that this bolt corroded within the wood to which the metal tram top was attached, and caused the wood to decay, weakening it.

When the tram is painted bolts such as this can appear identical to knots in the wood. See Fig 2

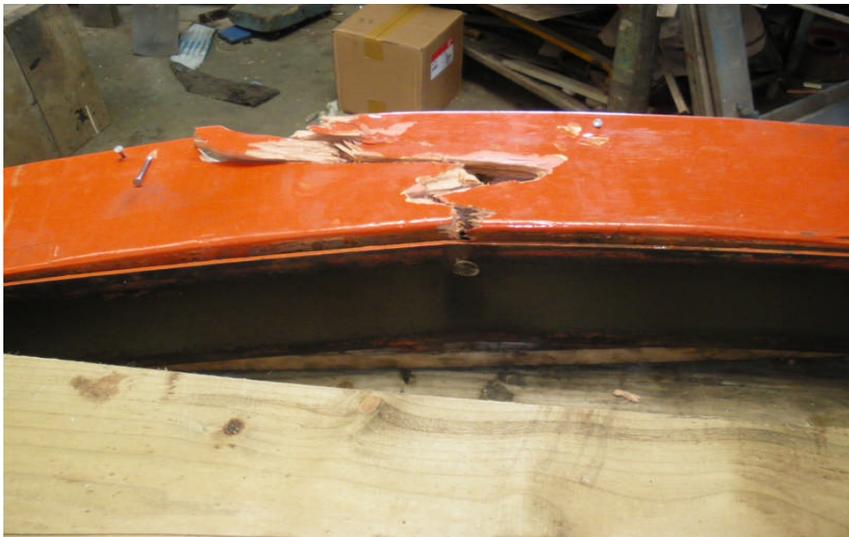
This weakening then resulted in a catastrophic failure of the timber support and the rail collapsed. See Fig 3.
