Number: S.B.QSR 001

SERVICE BULLETIN

Effective Serial Numbers: All Quasars

Subject: Cracks found on 'H' Frame.

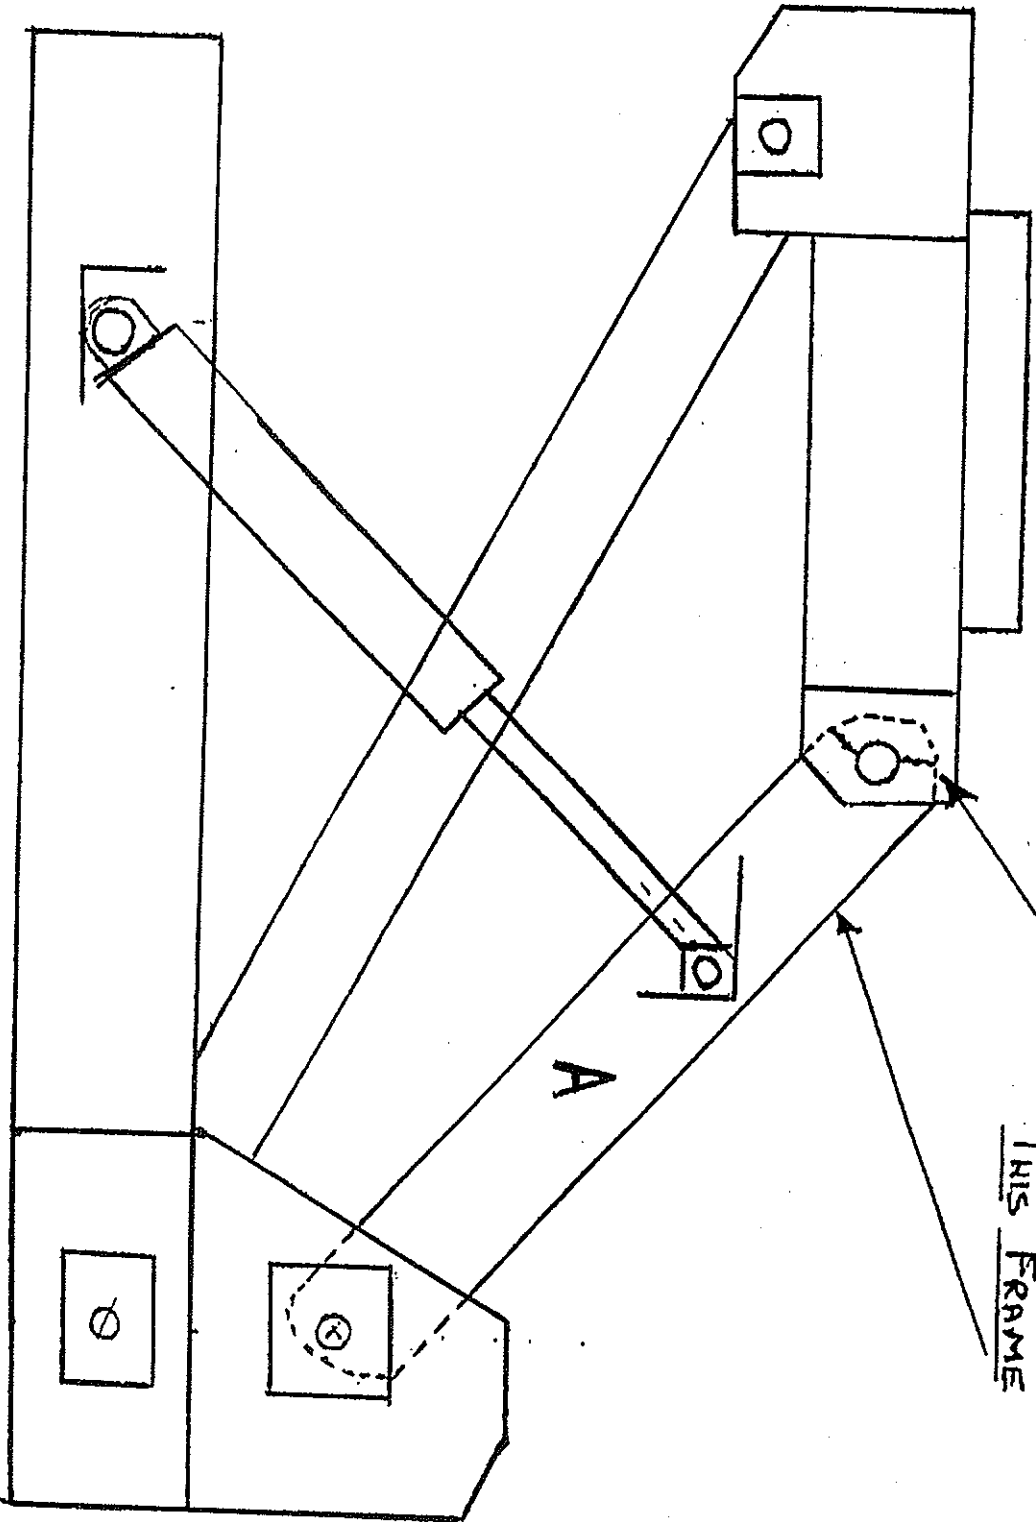
QUASAR SUB-FRAME

CRACKS FOUND ON 'H' FRAME AT THIS POINT
BOTH SIDES

THIS FRAME

All operators must inspect for cracks in this area. If any cracks are found, please inform the manufacturer and ensure that the ride is not used until repairs have been carried out.

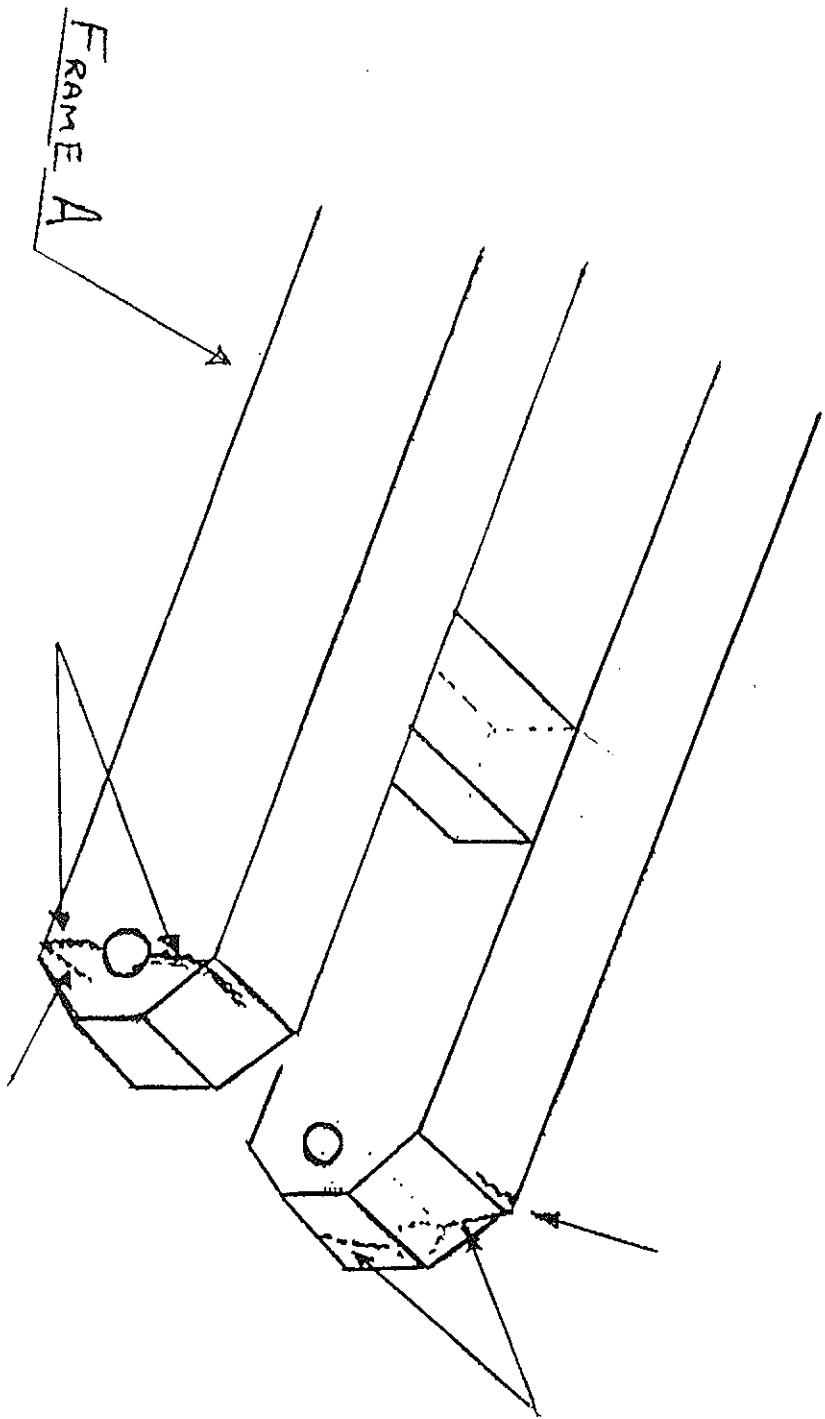
It has been noted that one Quasar has developed cracks on the 'H' frame upper pivot points, radiating from the hinge pin holes (see attached sketch).

CRACKS RADIATING FROM HINGE PIN HOLES BOTH SIDES
AND RUNNING ACROSS BOX SECTION
