Bulletin No: N031714
Release Date: March 17, 2014
Effective Date: Immediate
Supercedes: N/A
Completion Date: Immediate
Page: 1 of 1

SERVICE BULLETIN

Manufacturer: A.R.M. (USA), Inc.
 Ride Name: Fixed-Site Super Shot

Model(s): 1002 & 1003
 Production Dates: Prior To March, 2014

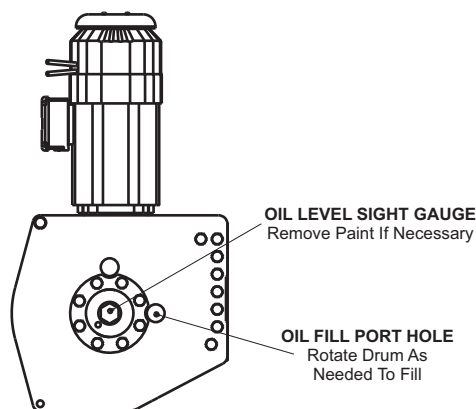
A.R.M. (USA), Inc. has become aware that certain auxiliary hoist units were supplied from the manufacturer without adequate amount of oil in the drum. Additionally, some units were supplied with the oil level inspection glass covered with paint.

1. Remove paint or debris from oil level sight gauge.
2. Rotate drum so fill port aligns with the indicated hole in the frame.
3. Check/fill oil level as specified in the Auxiliary Hoist Owner's Manual.

If the oil level inspection glass has been painted, it must first be cleaned for inspection. The oil reservoir must then be inspected and filled to appropriate level according to the manufacturer manual. Total oil capacity is approximately 7 pints. Manufacturer recommended oil is Mobilgear SHC 629 or 630 synthetic gear oil or equivalent
