SERVICE BULLETIN

Ride Name: CHAOS Affected Serial Nos.: 408-00196 through 408-04499

Model No.: 408

Abstract of Issue:
Boom Inspection

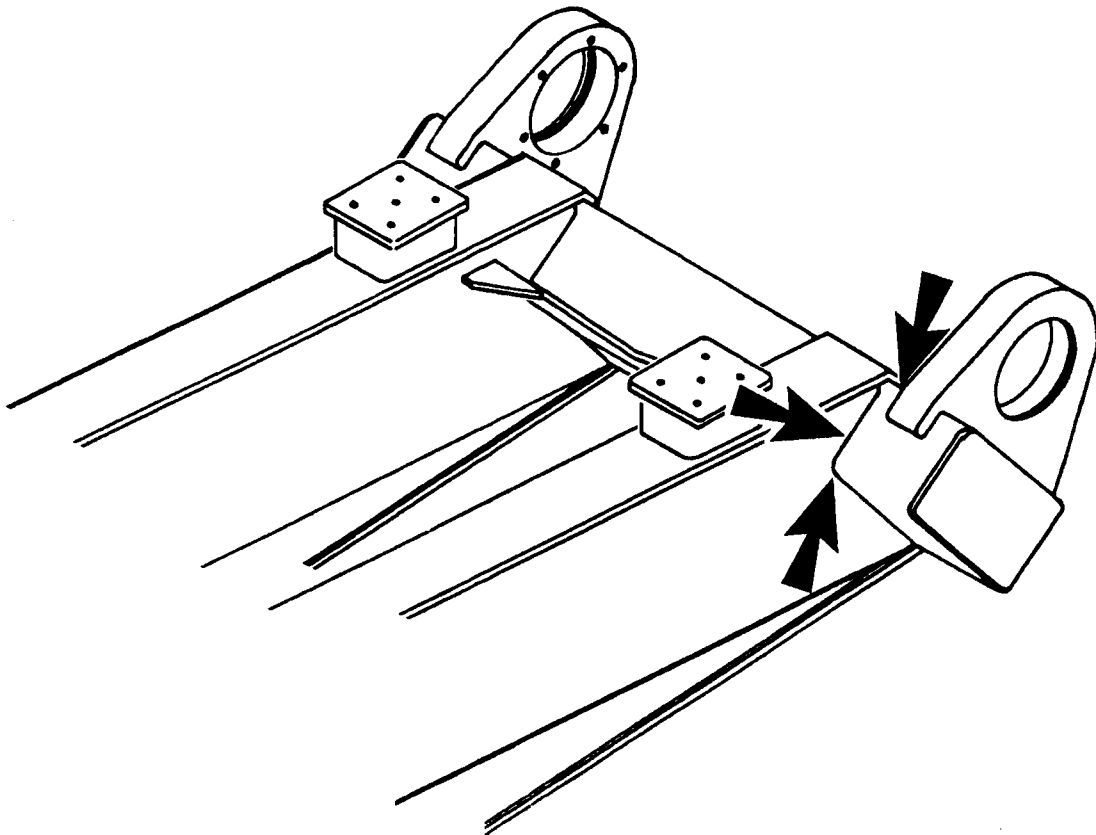
Chance Rides, Inc. has become aware that cracks can form in and around the tilt head mounts on the boom of the above noted CHAOS amusement rides.

1. Visually inspect both sides of the boom in the areas shown.
2. If any cracks are found, contact the CHANCE Customer Service Department.

Perform the inspection described on the next page of this bulletin. If any indications are found, contact the CHANCE Customer Service Department immediately for instructions on further action to be taken. DO NOT ATTEMPT TO WELD OR OTHERWISE REPAIR THE BOOM, EXCEPT AS SPECIFICALLY INSTRUCTED BY CHANCE RIDES, INC.
