CHANCE
MANUFACTURING CO., INC.

Service Information

YO YO

Rear Erection Cylinder Mount

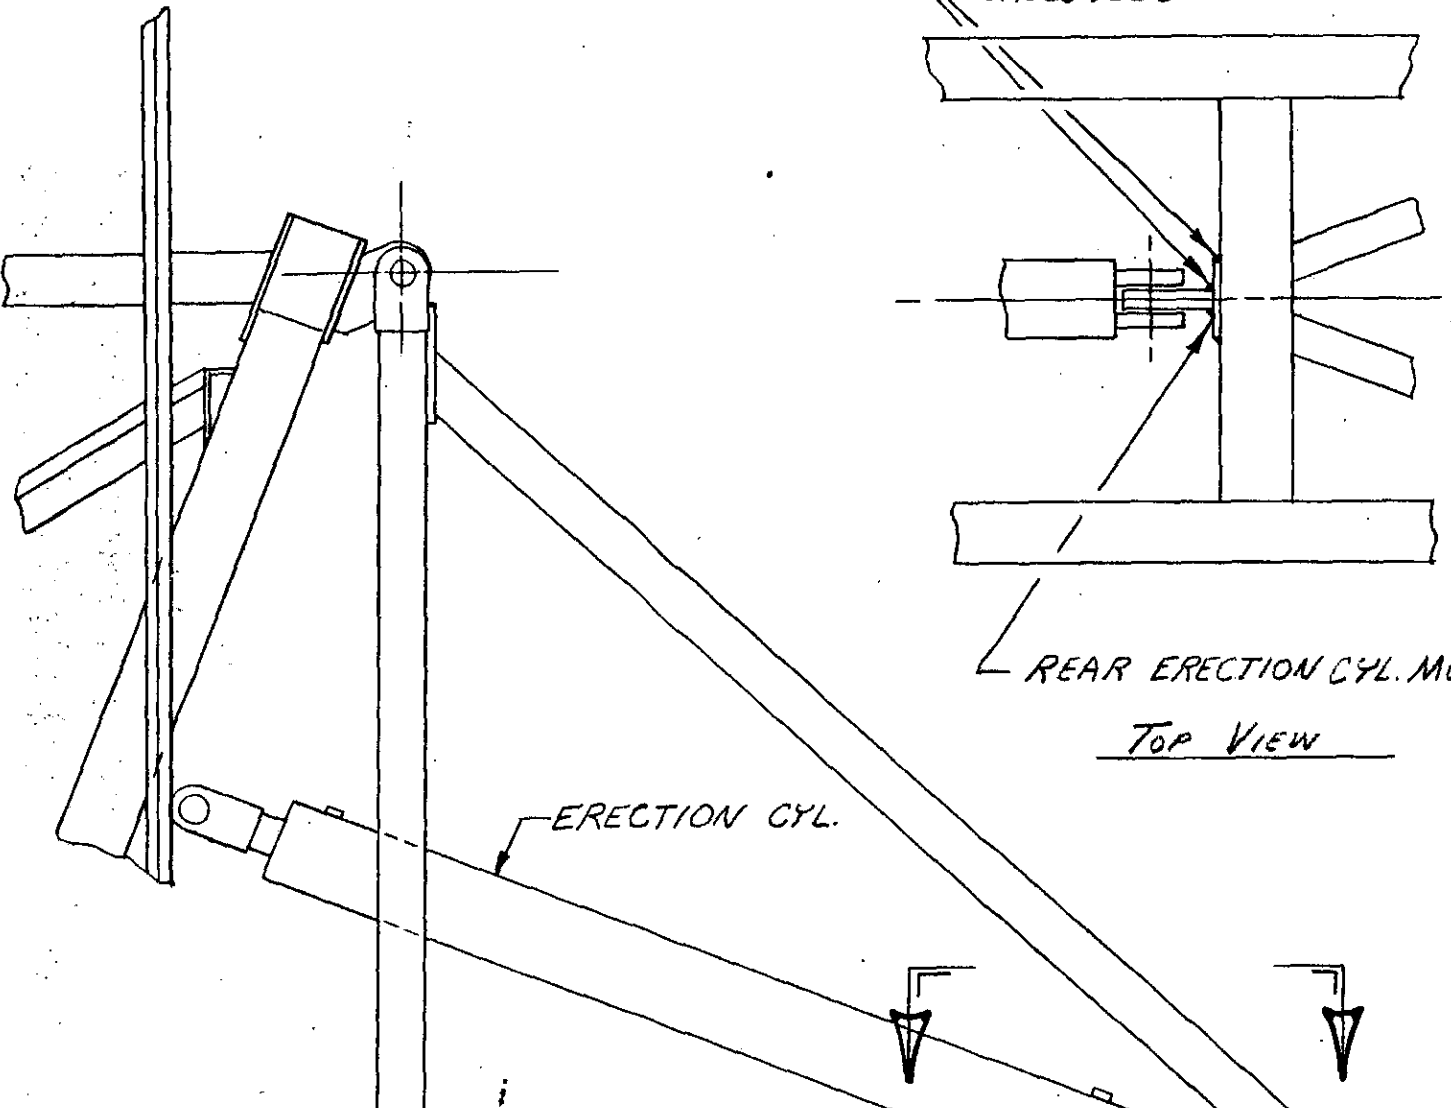
TOP VIEW

Recently we have become aware of a condition on the YO YO Ride that could cause a serious accident. The problem is in the area of the tower erection cylinder mount, shown on the back of this sheet. If your ride personnel reverse the direction of the tower lift cylinder with the tower stiff leg brace pinned in position, it may tear the rear erection cylinder mount off the trailer frame. This will allow the tower to fall when the pin is removed, which would have catastrophic results.

CHECK ALL WELDS AROUND
EAR & DOUBLER PLATE FOR
CRACKS & BULGING OF 6"x10"
CROSS TUBE

REAR ERECTION CYL. MOUNT

It is imperative that you check the rear erection cylinder mount immediately to see that it has not been broken or cracked. Also, you must alert your ride personnel as to this condition so they will not reverse the direction of the erection cylinder until the tower stiff leg pin has been removed.

In order to eliminate the possibility of this condition occurring, we are making a change in the hydraulic circuit that operates the tower erection cylinder. Please contact Richard G. Chance at the factory so we can schedule a service representative to make this change on your ride. This change will be made at no cost to you, and it is very important that you contact us immediately.

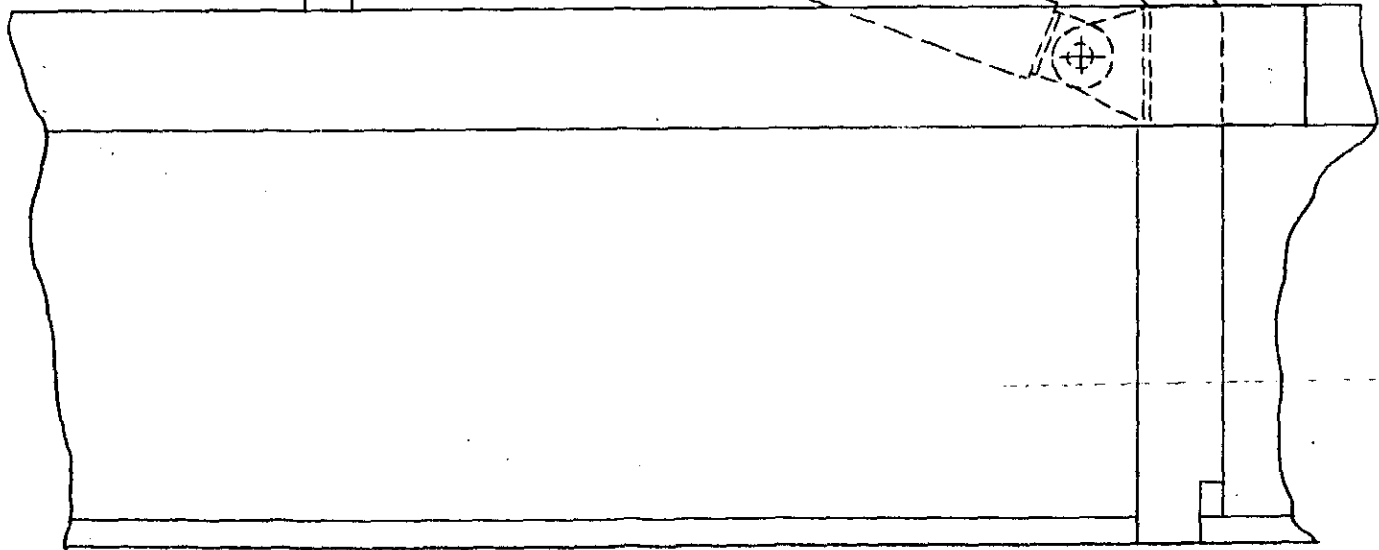
SIDE VIEW TRAILER

ERECTION CYL.
