DARTRON INDUSTRIES, INC.	Bulletin #	BU0201PR01
	P.O. Box 13114	Release Date:	01/15/2002
	Salem, Oregon 97309	Effective Date:	01/15/2002
	Phone: 503-362-2341	Supercedes:	
	Fax: 503-362-2536	Completion Date:	N/A
		Page	1 of 1

SERVICE BULLETIN

Ride Manufacturer: Man-Co Mfg. Kilinski Mfg. Frank Hrubetz Co.	Affected Production Dates: All
Ride Name: Round-Up, Paratrooper	Affected Serial #'s: All
Model Number: All

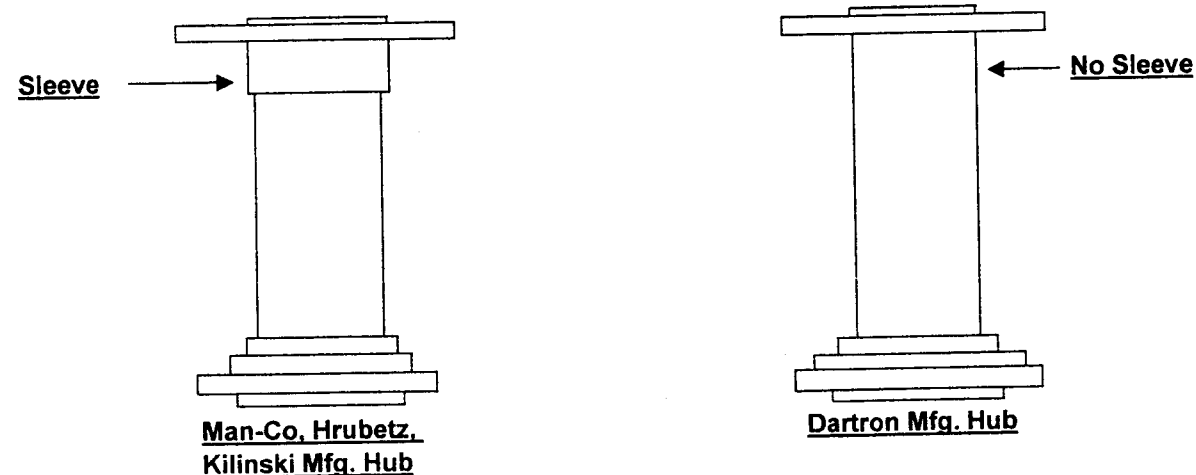
To determine whether a Round-Up or Paratrooper hub was manufactured by Dartron conduct a visual inspection. If the hub is on a Paratrooper and is a "split type" it does not require the NDT inspection. A "split" type hub allows all sweeps to be rotated to the rear of the trailer for transport. If it is not a "split" type hub inspect for the sleeve as shown below.

Below is the sketch indicating the difference between the old style hub and the Dartron hub.

It has come to the attention of Dartron Industries that unnecessary inspections are being performed on new Paratrooper and Round-Up hubs. Dartrons position on this matter is that Round-Up and Paratrooper hubs manufactured by Dartron, do not require an annual NDT inspection.
