412.

Reverchon Crazy Mouse support column track allocation cone cracking and Spinning Coaster wheel carrier unit cracking

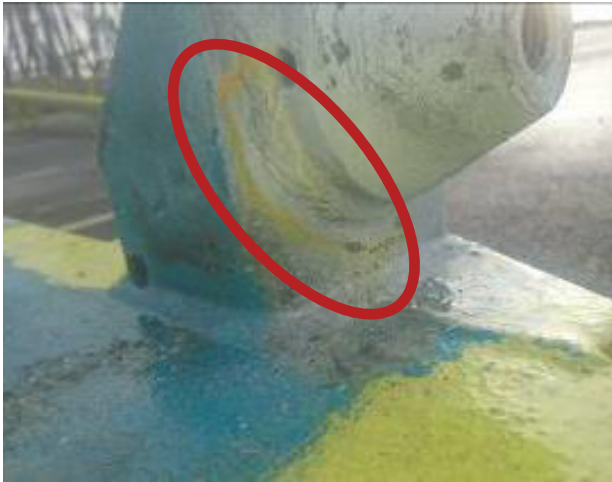
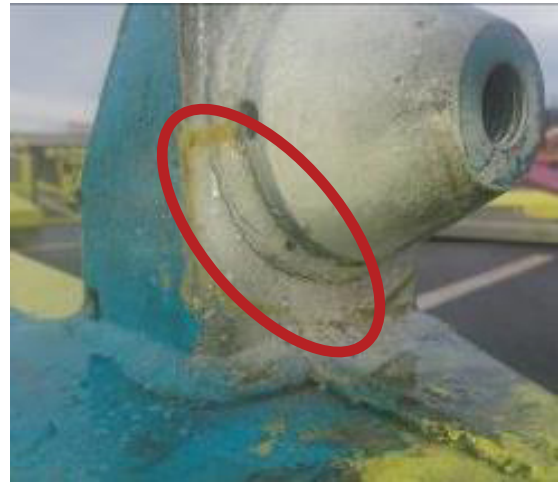
Numerous areas of cracking have been found on the support column track location cones of a Reverchon Crazy Mouse coaster manufactured in 1995. These were discovered via MPI and visually and are situated on the cone connection into which the track sits (see accompanying pictures). There is restricted access to these areas because the coaster track is connected onto them so inspectors are advised that they may have to consider lifting the track off the cones for inspection purposes.

▲ Reverchon Crazy Mouse support column track allocation cone cracking

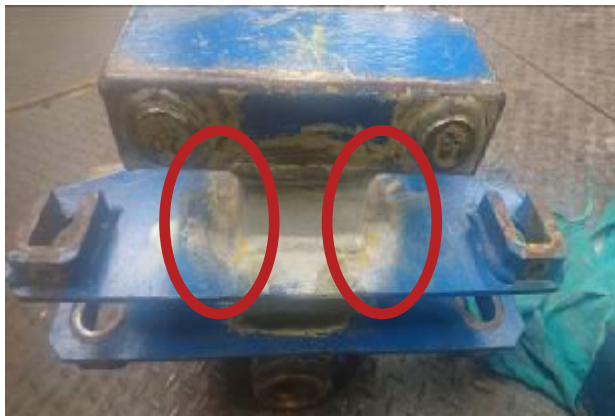
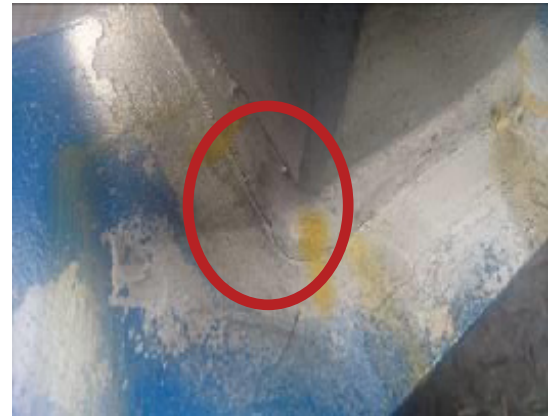
Additionally, cracking has been found on a 16 year old Reverchon Spinning Coaster wheel carrier unit, again via MPI and visual inspection. The items are easily accessible for inspection purposes.

▲ Reverchon Spinning Coaster cracking
